THE STANFORD WHITE TRIPLE PORTAL

**ST. BARTHOLOMEW'S
CHURCH**

Building Diagnostics and Conditions Survey

Columbia University
Graduate School of Architecture, Planning and Preservation
Historic Preservation Program

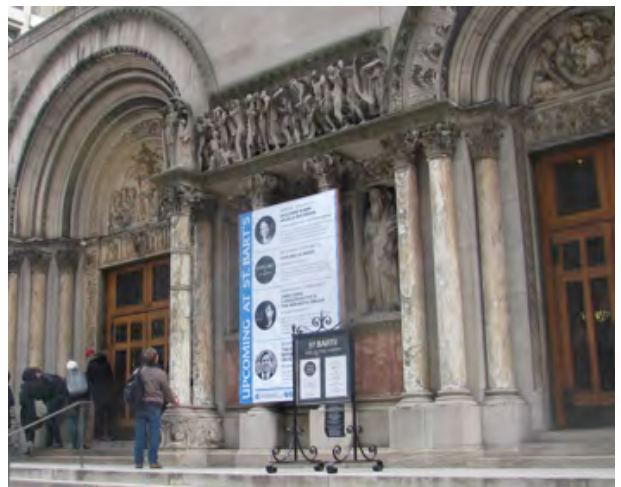
(Left) Central and southern Portal arches with bronze doors and attached sign between columns c. 1950. Photo courtesy of St. Bartholomew's Church Archive. (Right) Central and southern Portal arches with current sign, 2017.

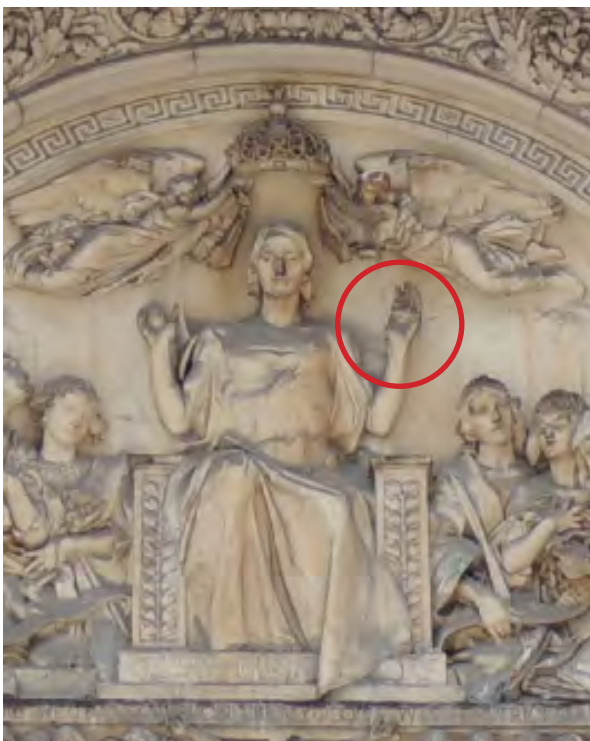
Missing fingers of the central sculpture are indicated at left with the red circle.

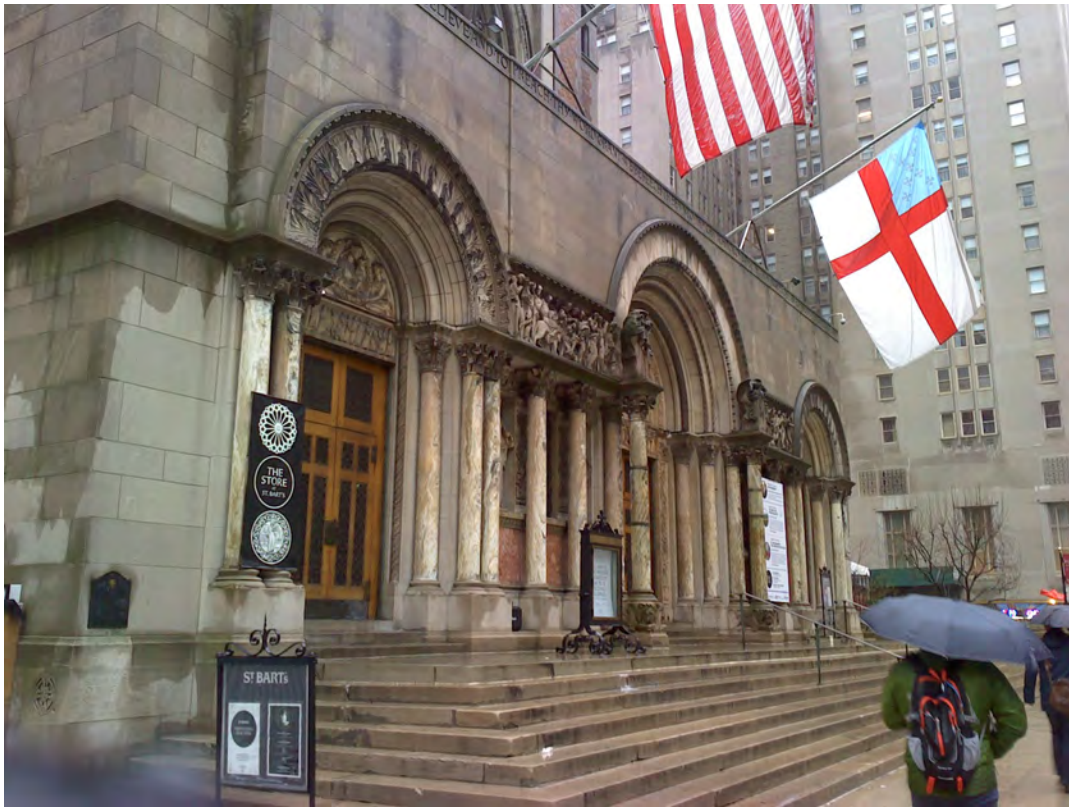
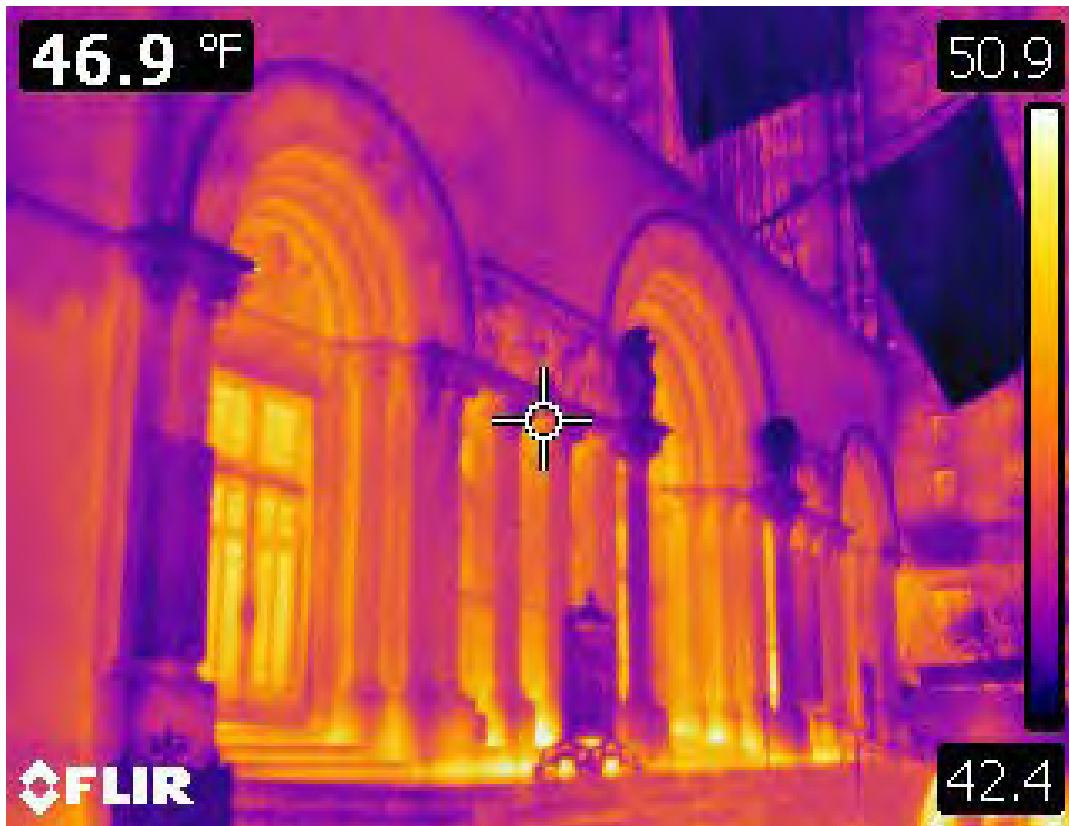
This first image pair demonstrates that on the whole, surfaces most heavily exposed to the rain (including the prominent statues flanking the central doorway) are distinctly cooler than more recessed portions of the Portal. On a day ten degrees cooler than the day when this image pair was recorded, water on some portions of the Portal would actually freeze. We might therefore expect that some of the most prominent features of the Portal are more frequently exposed to freeze-thaw cycling, whereas those portions that are recessed are buffered from the cold.

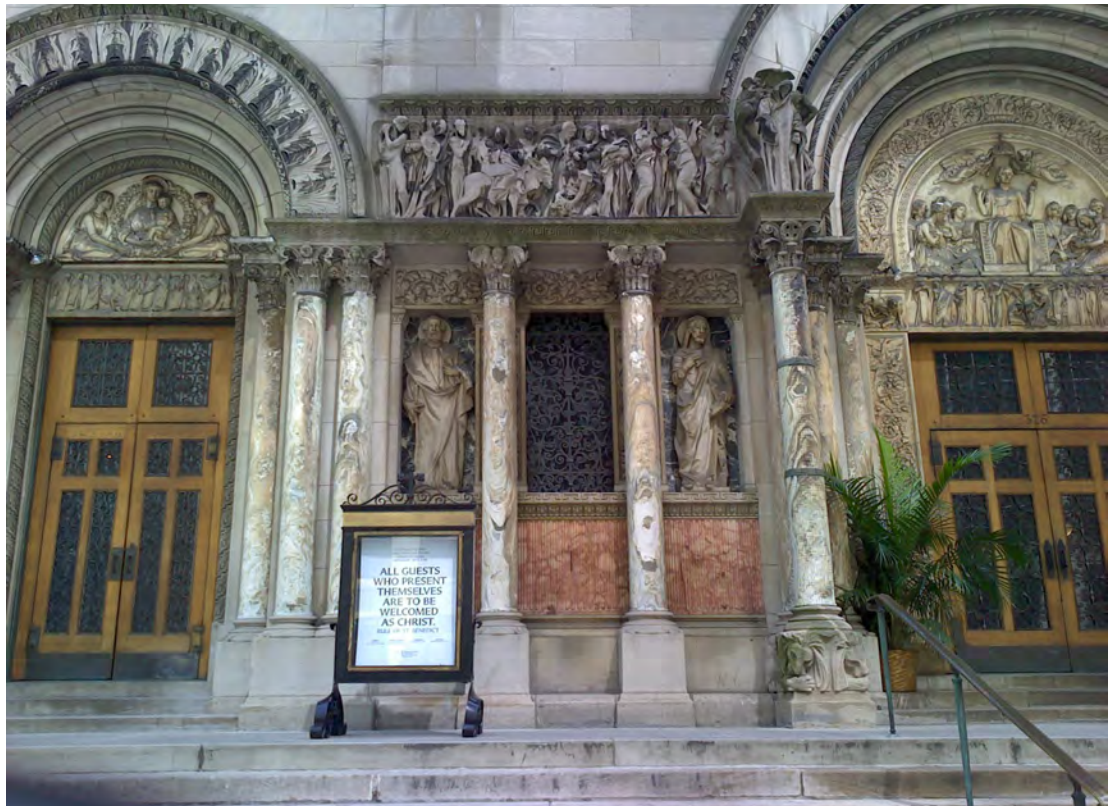
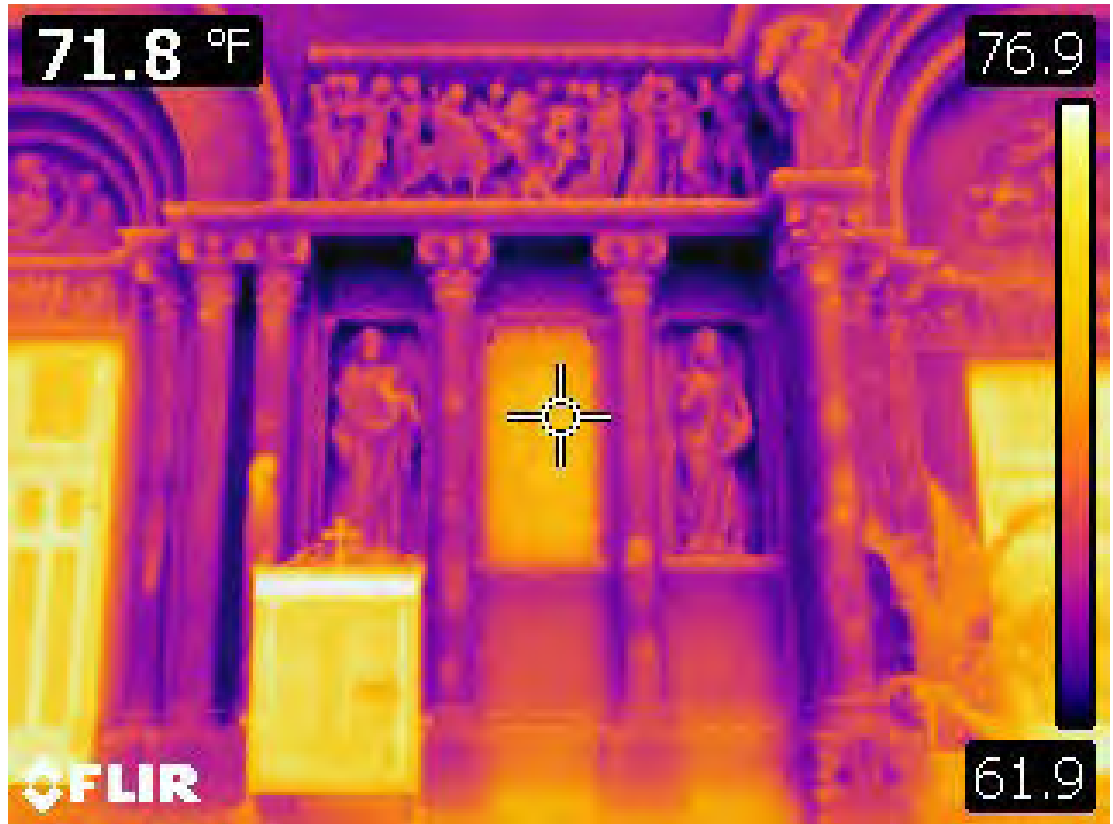
This image pair was recorded on a different, warmer day with no precipitation. It shows how much heat is transmitted from the interior of the building through the doors and windows leading to the Narthex. Also note the distinctly lighter (warmer) patch on the third column from the left. This is the cementitious patch applied as a cosmetic fix to the deteriorating Cipollino marble. The different thermal properties of this patch will ultimately contribute to it separating from the column, and it will eventually need a remedy.

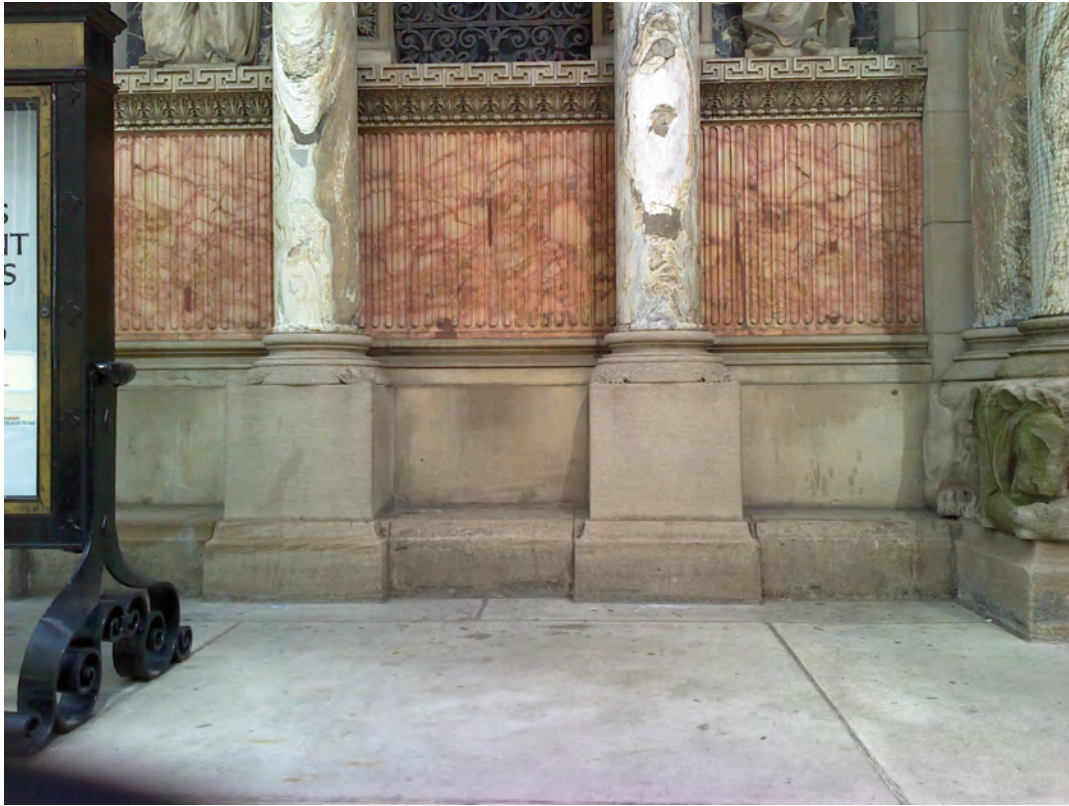
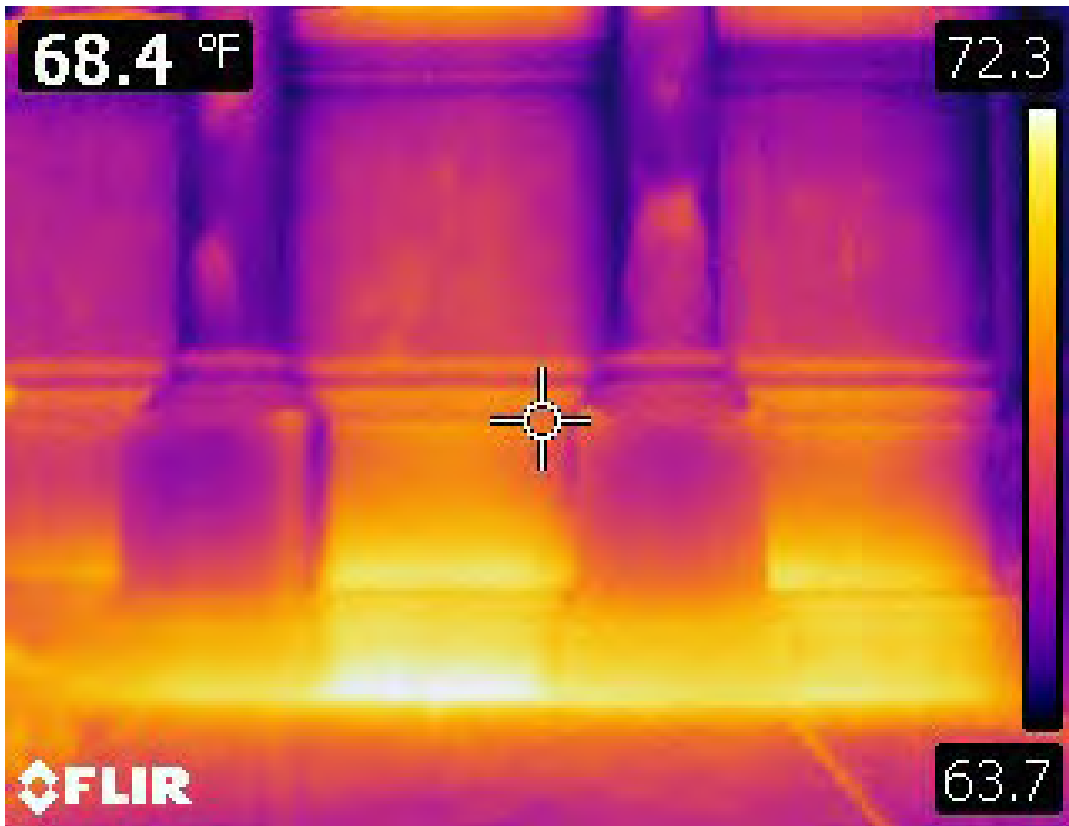
This third image pair demonstrates how much heat is being lost through the masonry at the base of the Portal. The steam heating system in the interior of the Narthex is likely the source of this heat, but the heat loss provides the lower portions of the Portal with a buffer against the damaging effects of freeze/thaw cycling.

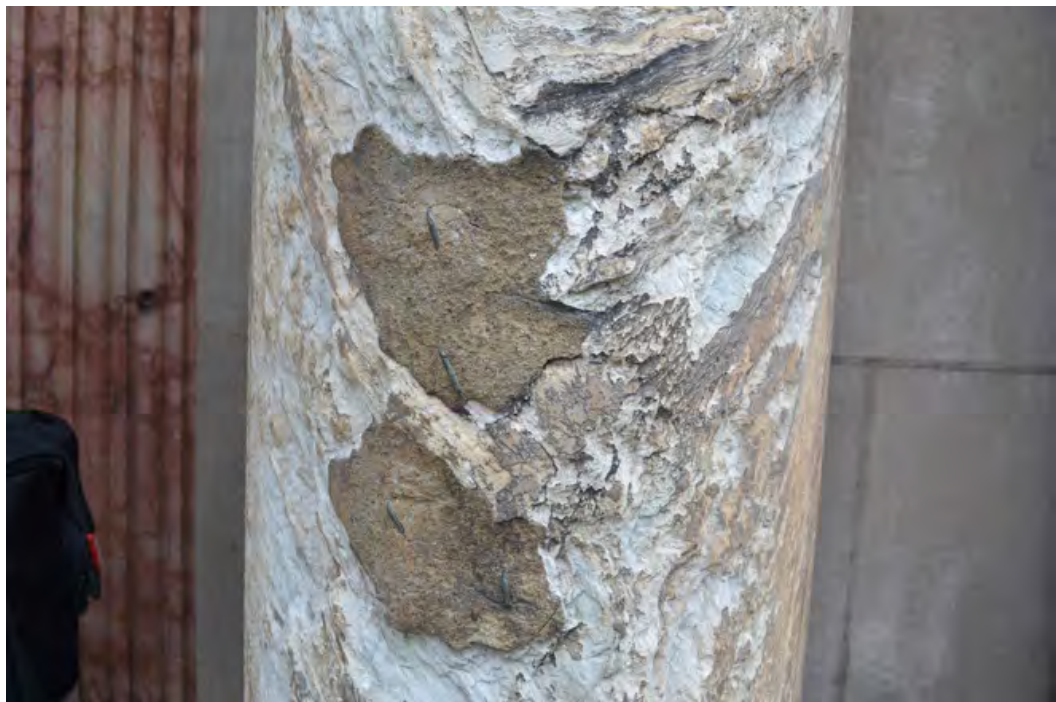
One particularly discolored patch that could be replaced.

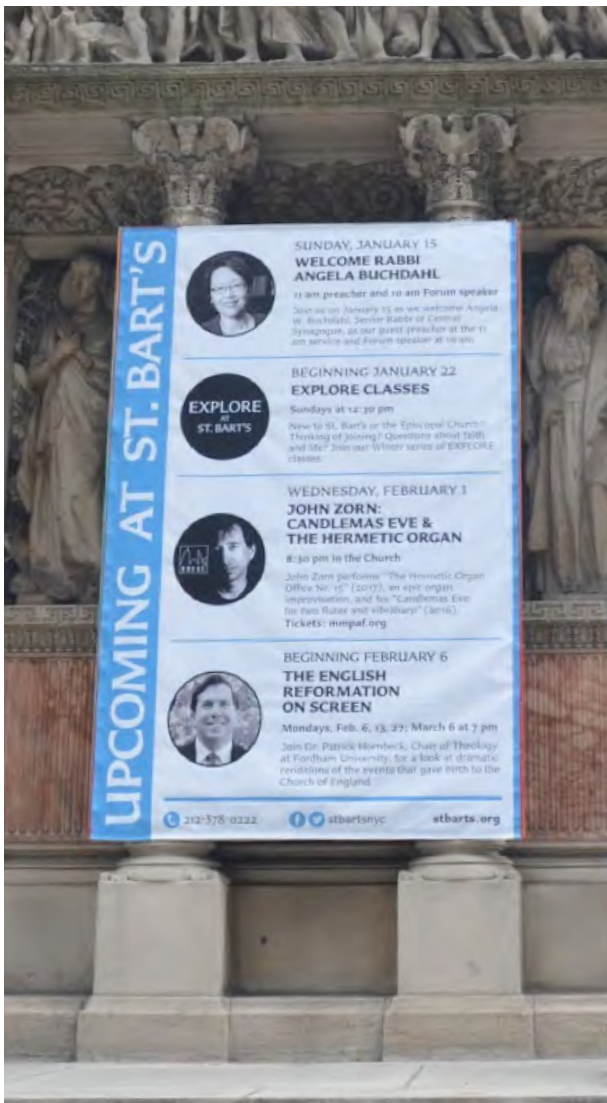
Sign attached to Cipollino columns that should be removed to prevent the wire attachment from abrading the columns any further.

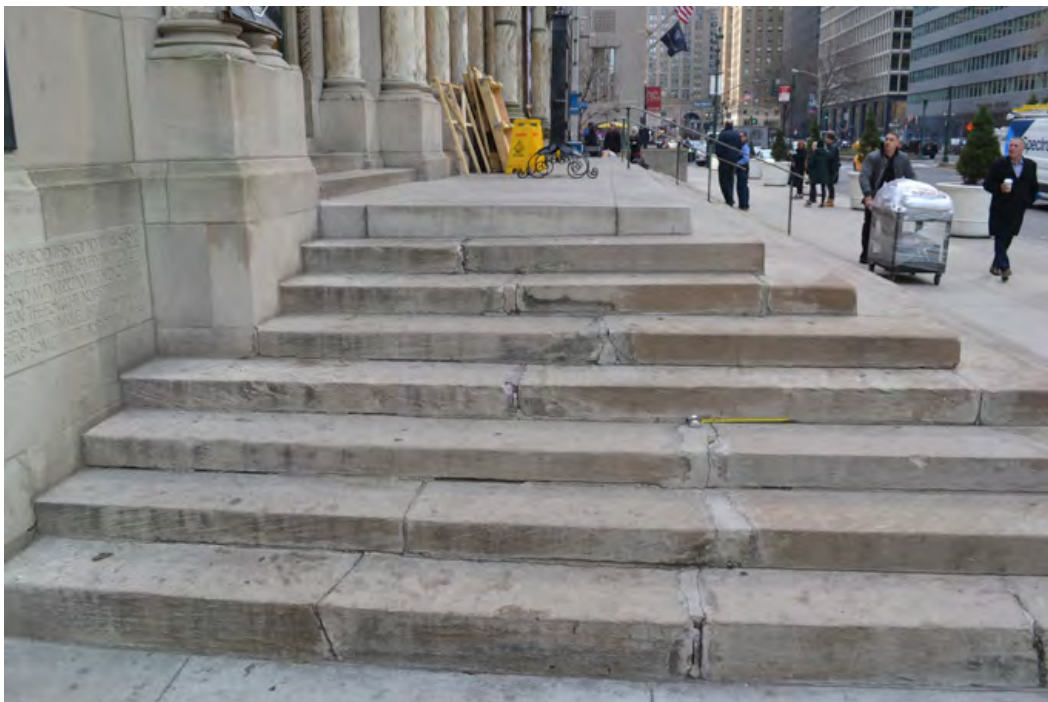
Likewise, the limestone steps leading up to the Portal are cracked due to differential movement of the slabs. The cracks can be patched, but the patches will not hold unless an expansion joint is installed before the repair is made. The Conservancy's plans call for a full restoration of the limestone steps.

Substantial crack in northwest corner of stairs leading to the portal.

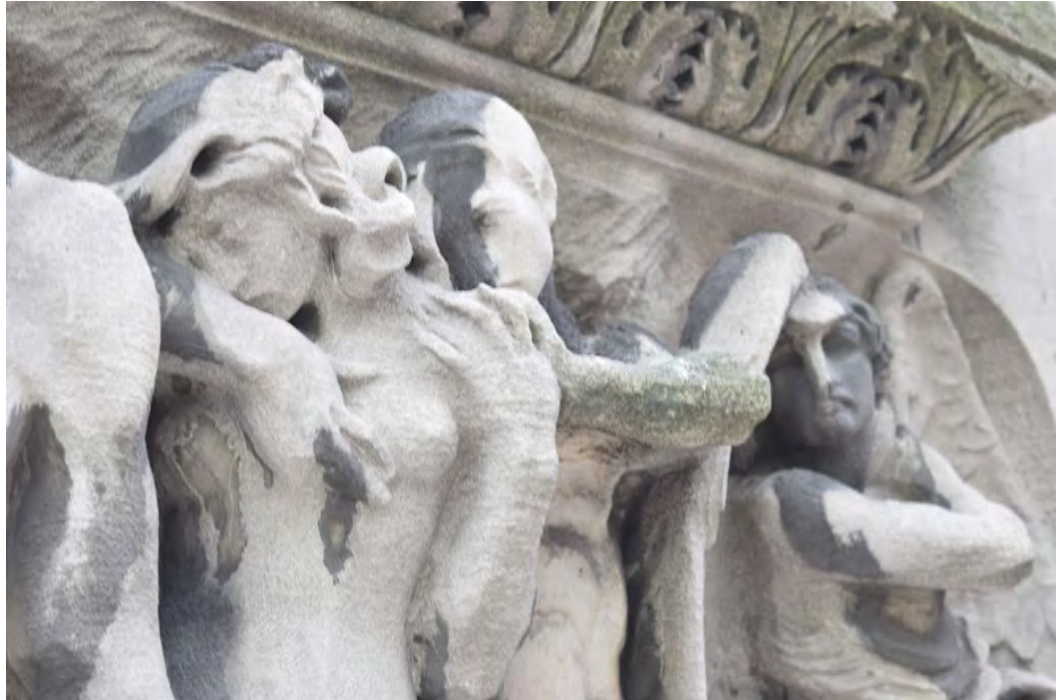
Finally, the sculptural elements are severely soiled. Since these sculptures have always been one of the most highly regarded aspects of the Portal, and since they are a physical manifestation of the gospels disseminated by the church, they deserve to be made (and kept) more legible.

Heavy soiling and jarring contrast between light and dark make the sculpture more difficult to read from ground level.

A necessary first step would be to clean them with water using a low pressure wash for at least twelve hours to remove the heavy accumulation. This would reveal the true conditions of the sculpture, which cannot be readily discerned at present.

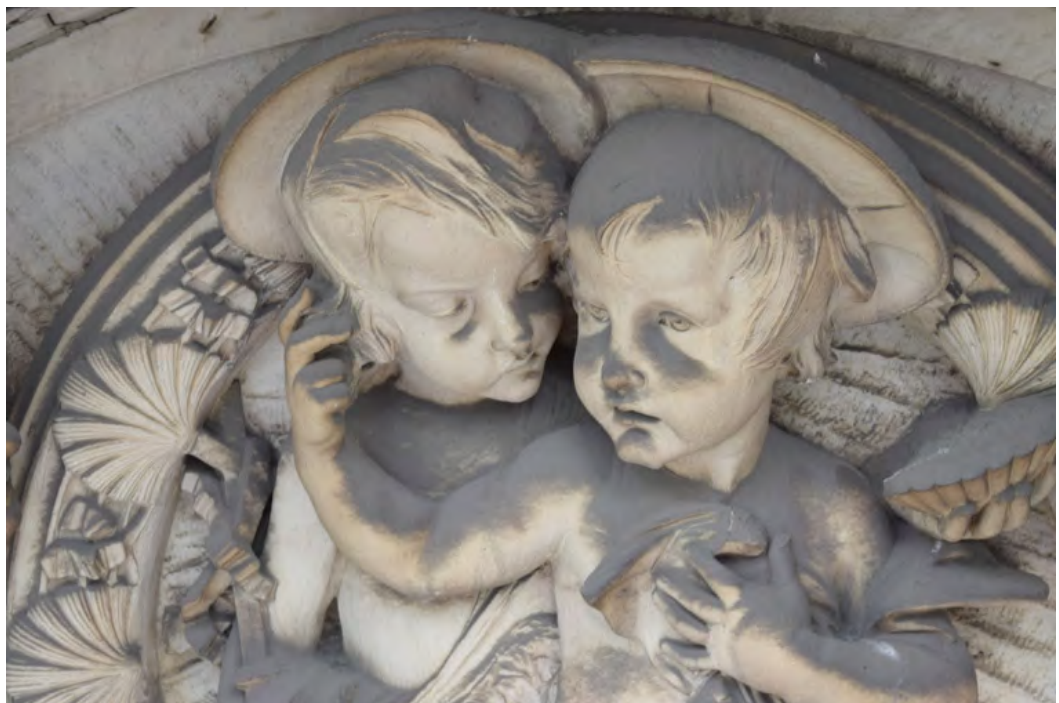
Much of the heaviest soiling may be removed by low pressure washing over a period as short as 12 hours.
