The Stanford White Triple Portal

ST. BARTHOLOMEW'S CHURCH
NEW YORK, NEW YORK

Conservation Evaluation Summary Report

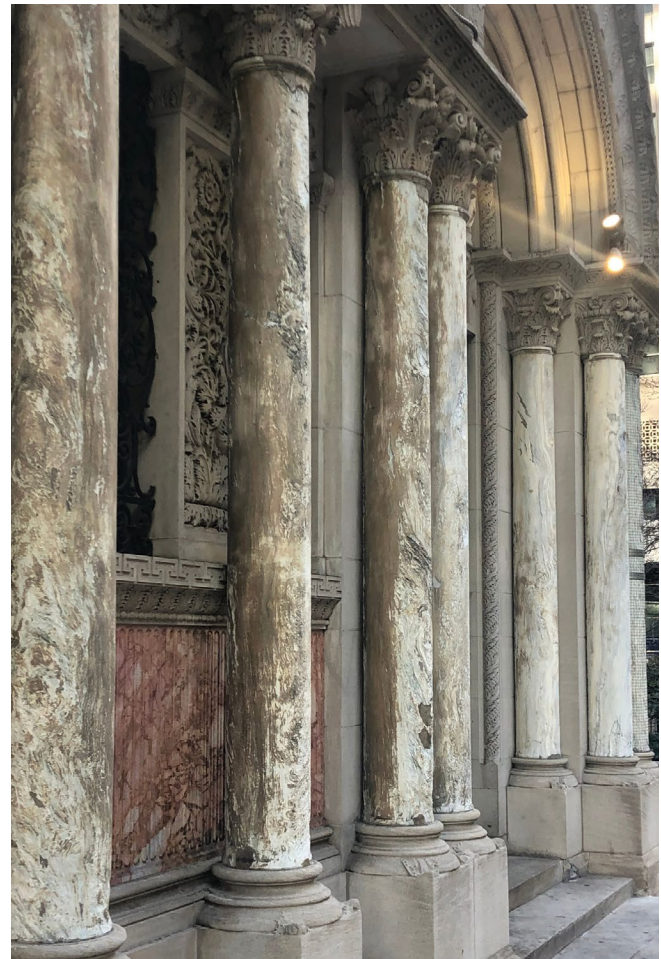
Cipollino Marble Columns.

The CU Survey identified several issues of concern with the columns' state of conservation. Noted therein is **Loss** in the form of **light to heavy erosion and spalling and light to heavy general soiling** of surfaces present to varying degrees on all columns. Several of the columns have been **repaired with cementitious patches**, which are incompatible and

mismatched, and some columns are encircled with **metal bands and netting** purportedly installed for stabilization.²

Firstly, the columns require initial phased stabilization of incipient spalls with selective applications of conservation-grade adhesives based on epoxy resins and/or ethyl methacrylate co-polymer and/or lime-based hydraulic injection grout to minimize losses. The subsequent removal of prior interventions (metal bands, netting, and mismatched cementitious patches) may proceed cautiously. If necessary, any newly exposed conditions can be assessed and treated.

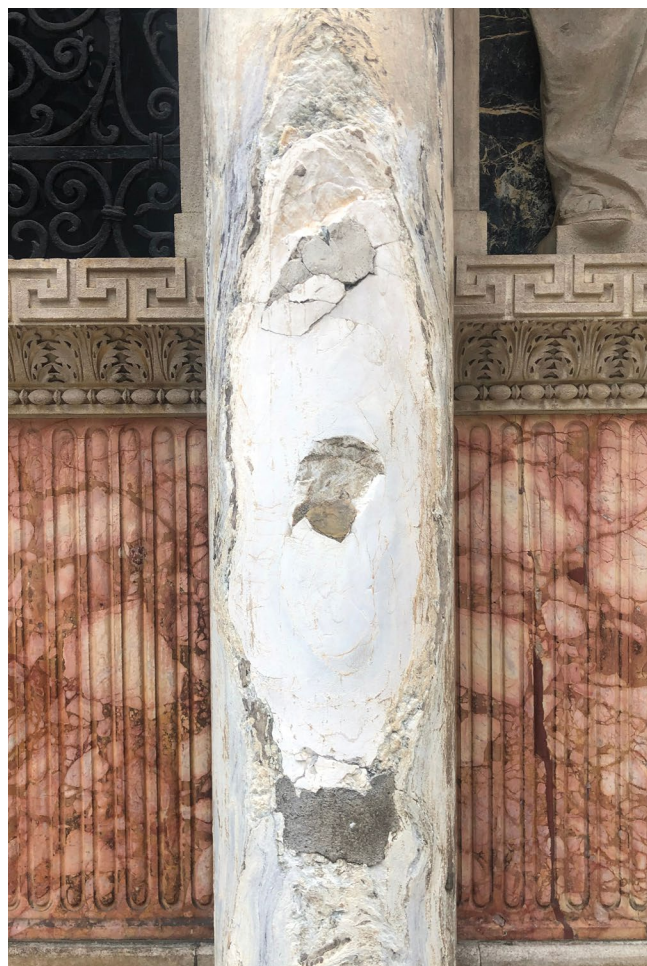
The Excelsior Evaluation found that the columns' existing patches are predominantly unsound and failing due to poor bond strength and differential thermal expansion. The patches are composed of different materials and have an inconsistent and distracting appearance. The obtrusive metal bands encircling the columns are of questionable purpose and may even be adversely affecting them due to differential expansion/contraction. The bronze bands located on the columns at the sides of the central doorway have oxidized, and runoff has stained the adjacent marble surfaces with a greenish cast.

Detail: Incompatible/Mismatched Patches.

existing failed cementitious patches and the integration of new patches in proportion to the previous repairs. This will stabilize surfaces and maintain the integrity of the columns' form. In many cases, the existing patches have already disbonded from the substrate, i.e., they no longer adhere to the substrate. This is indicated by a hollow sound that emanates when they are tapped. Their removal may consist of gently scoring and fragmenting the patches where necessary to safely disengage them. Skillfully matched and applied patch material, a cementitious compound based on suitable aggregates of similar composition, color, and gradation to the marble substrate, and that are suitably durable, well bonded, dimensionally and chemically stable, is recommended. As with the grout fills, the new patches should be detailed to stabilize surfaces and shed rainwater away from areas vulnerable to damage from infiltration. While smaller patches will be self-supporting, larger voids may be

reinforced by integrating non-reactive fiberglass rods to span the void and mechanically engage the marble, thus providing additional stability to the column.

The new patches should be tooled and pigmented to make them subtly detectable as restorations. A palette of options is available for determining the visual appearance of patches. Treatment may range from a uniform neutral coloration, to surface in-painting, to the use of scagliola, a traditional technique employed to simulate the marble's unique veining and colors throughout the depth of the patch.

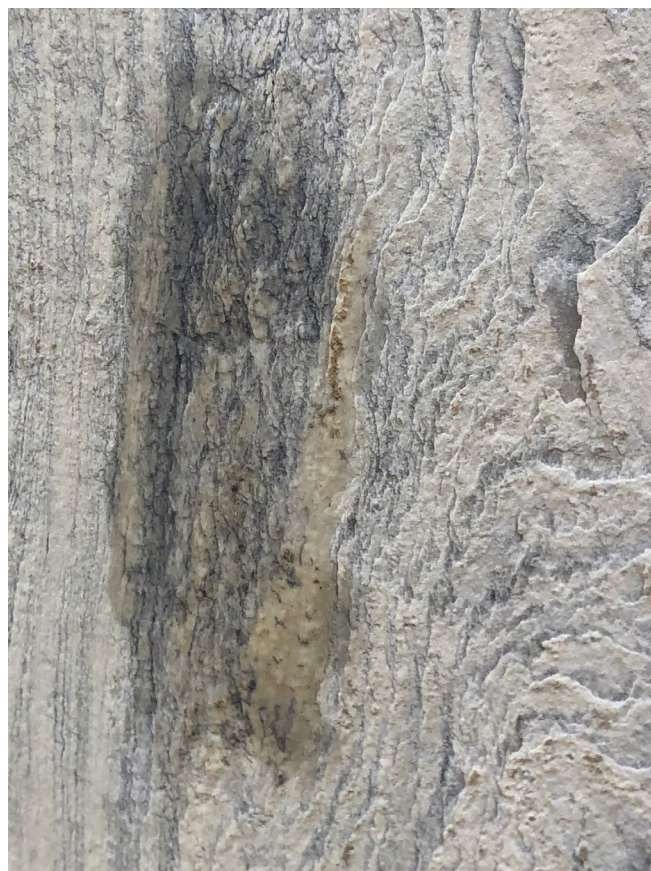
Simulation of Protective Coating Visual Enhancement.

Lastly, the mockup applications of protective coatings such as microcrystalline wax, acrylic silane solution, or silicon dioxide-based conversion consolidant should be tested and compared for performance. The selected coating may enhance the newly cleaned columns' reflectance and subtle coloration as was intended by its designer, and if suitable, may be applied globally and refurbished as needed.

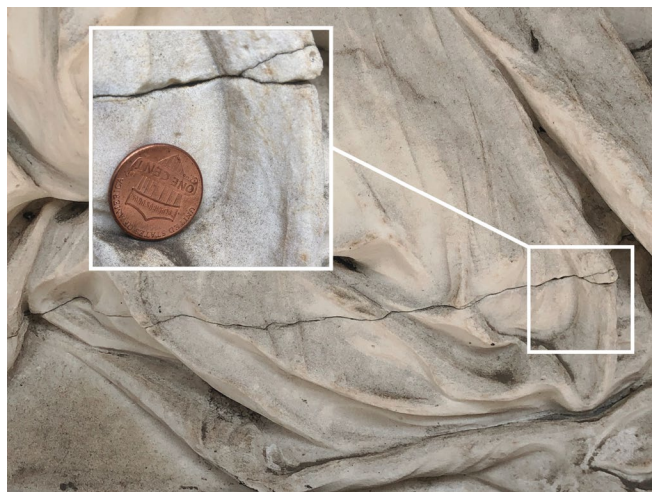
Large Lateral Crack Bottom Left, Central Tympanum.

Lastly, filling/stabilizing cracks is recommended on the central tympanum and frieze with conservation-grade adhesives based on ethyl

methacrylate co-polymer, and/or lime-based hydraulic injection grout.

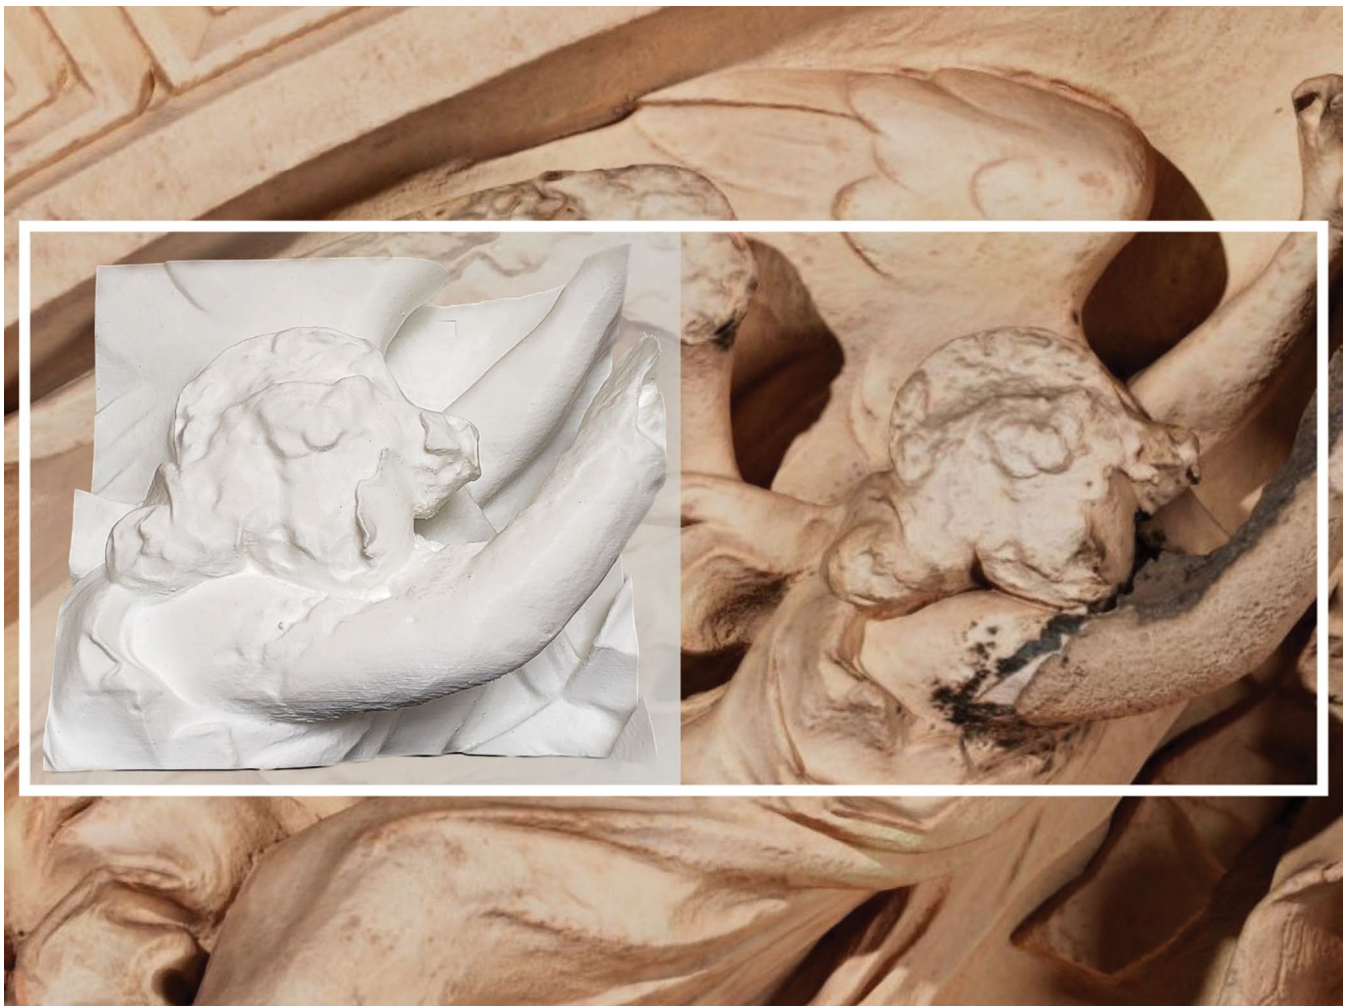
Actual Scale 3D Printed Model (at Left) that Can Support the Restoration Process.

Select marble sculpture that is most crucial to the legibility of the iconography, specifically the Christ figures of the central tympanum's Coronation and the central frieze's Crucifixion, may be prioritized for restoration. Other areas of sculptural loss may be stabilized and left unrestored.

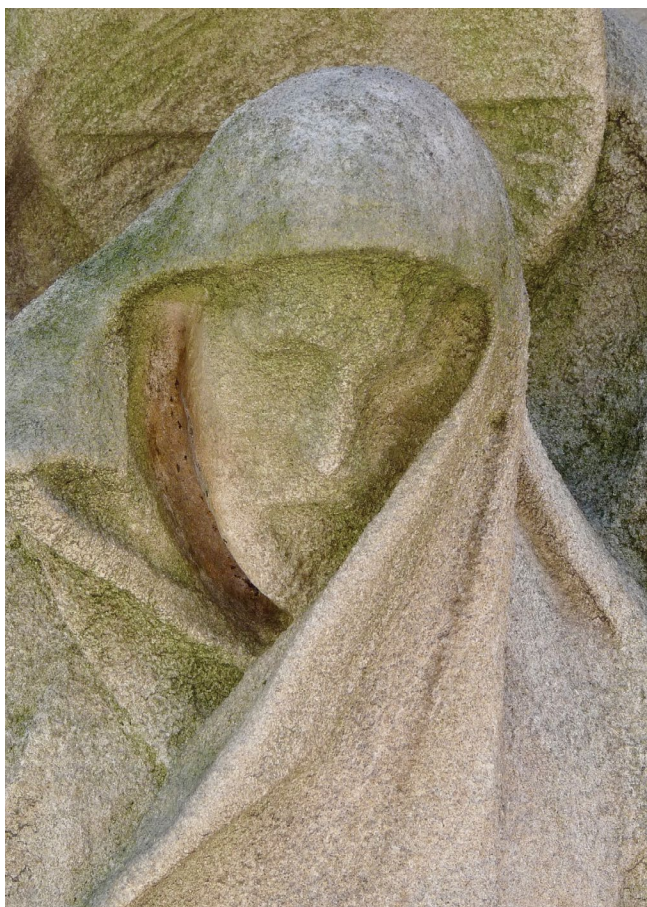
The CU Survey noted **Loss** in the form of **light to heavy erosion of surfaces** and **light to heavy general soiling** on most of the Triple Portal's sculptural and decorative surfaces. Biological growth was noted on prominent limestone sculptures and atop decorative limestone architectural courses.

Detail of Biological Growth on Limestone Sculpture.

It is highly recommended that the Conservancy underwrite a monitoring and preventive conservation regime for the Triple Portal's exterior. This should include engaging conservators to periodically (every 3-5 years max.) gently remove accretions of fine particulate matter from the facade and sculptural elements by soft brushing, vacuuming, and/or non-pressurized water misting.

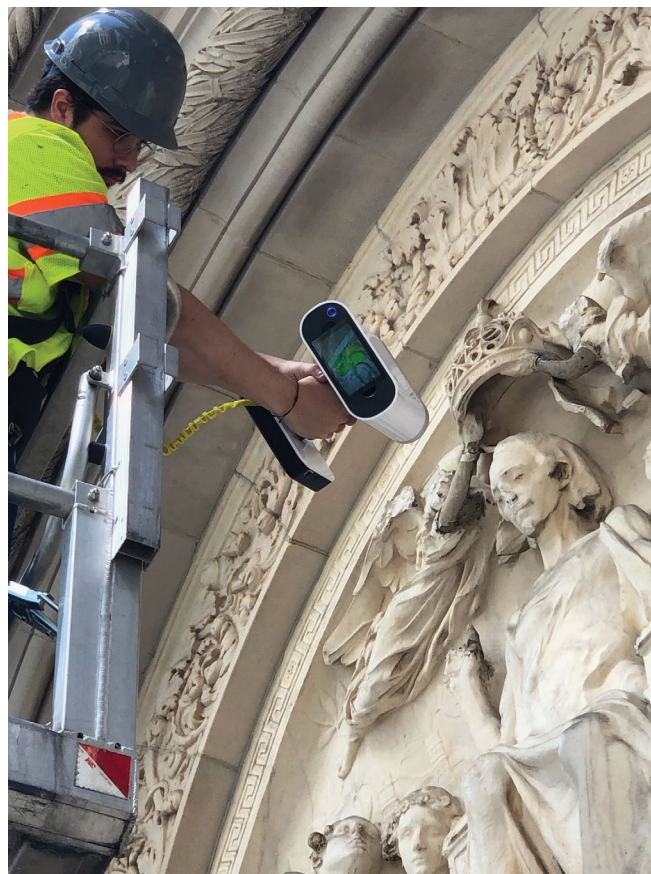
High Resolution Scanning of Iconographic Sculpture.

With the Conservancy's digital scan data captured in May 2023 by Direct Dimensions, Inc., virtual restoration of losses of the iconographic sculpture may be achieved remotely without impacting the Triple Portal's fragile materials. For details about the scans and their potential, see Data Capture and Processing Explanation for St. Bartholomew's Conservancy (Appendix 9) and Conservator's Notes by Excelsior Art Services | Digital Documentation—The Stanford White Triple Portal of St. Bartholomew's Church (Appendix 10).

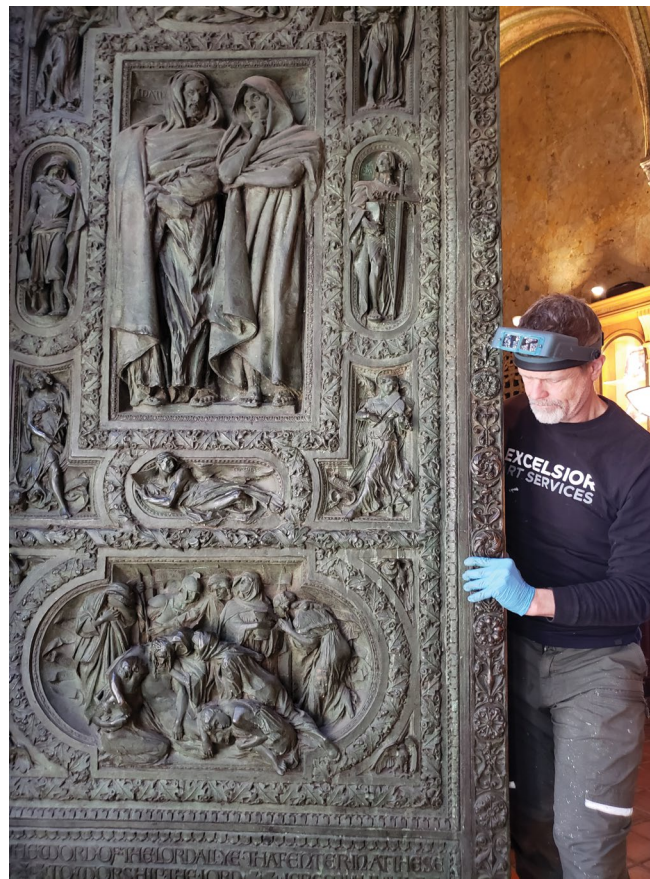
Excelsior noted an issue of concern in the form of **Repairs – inoperable and damaged;** and found that although all three sets of doors can freely swing into relatively open

and closed positions, each has issues with broken hardware and alignment with their respective leaves and integral frames. This is felt most keenly with the larger, central pair of bronze doors, particularly the north leaf, which exhibits damage/distortion from being forced into position. A section of the north door's decorative trim nearest the ground was broken off and lost. Evidence of probing was revealed on the door frame behind the lost trim, where a roughly cut opening was likely made to inspect the interior. Attempts to remove a panel on the back of the door to access the inner workings also appear to have been made, but no record of such interventions seems to exist.

Evaluating Operability of Bronze Doors.

receive repairs to their hardware and integral frameworks. The compromised operability of the center pair's north leaf may be addressed by adjusting the integral pivots and the doors' surrounding framework to allow the artwork to be strategically orientated towards Park Avenue when desired. Highly qualified specialists should be engaged to repair and conserve all three sets of doors in situ.

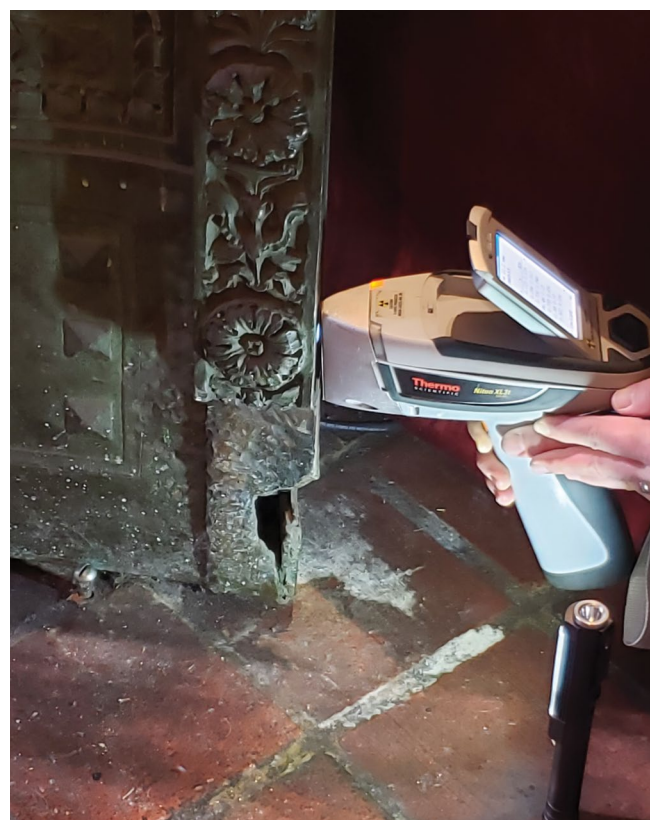
In February 2023, Excelsior directed a materials sampling in collaboration with SOCOTEC Specialty Engineering to identify the bronze alloys of all the doors. The report's findings are revelatory information for the art historical record and enable faithful in-kind replacement of the lost decorative trim. For more details on the testing results, see Bronze Cast Alloy Material Analysis — St. Bartholomew's Church by SOCOTEC Engineering (Appendix 13).

XRF Reading on Lost Decorative Door Trim.

Restoration work should include faithfully replicating the missing bronze decoration with the supportive use of 3D scanning technology combined with traditional crafts. The resulting bronze cast of matching alloy may be precisely integrated by TIG welding and carefully chased to match the existing trim's profile. The heritage patina of the bronze doors may be closely matched by applying heat and chemical solutions. The doors should be comprehensively deep-cleaned (solvent/aqueous and anionic/nonionic surfactant/detergent) and finished with

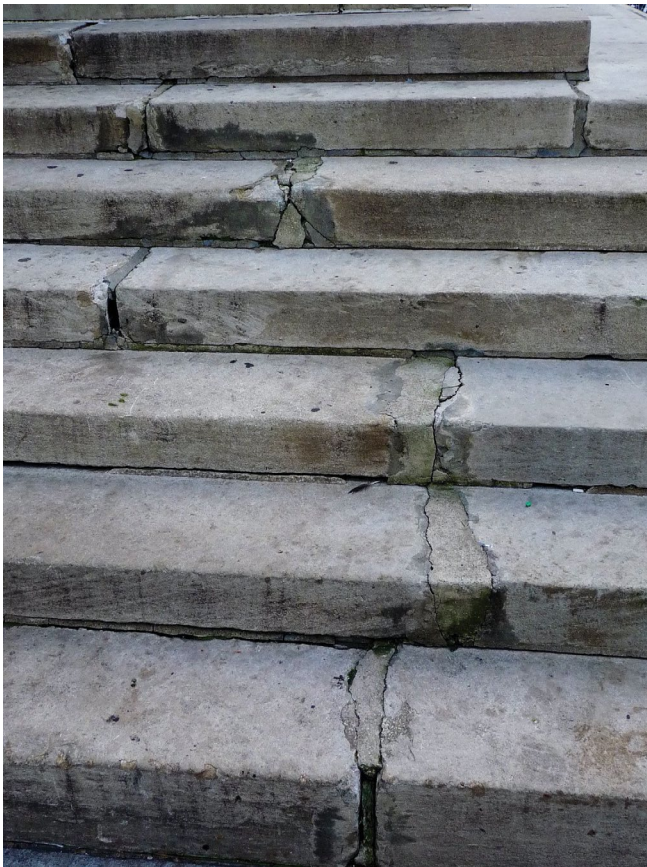
The CU Survey found the stairway has cementitious repairs to address a large structural crack on the north side due to heaving and the placement of a utility trench at sidewalk level that may be undermining it.

Several treads are cracked, and some pieces are slightly misaligned. Multiple patch repairs were also noted. The stairs are lightly soiled, and metal signs and railings have stained the limestone where they are in contact with it. As with the Triple Portal’s other carbonate stones, the stairway treads’ once crisp edges are softened from the effects of weathering and wear.

Large Structural Crack, North End Stairway.

The following recommendations are made to renew the integrity and use of the historic stairway designed by Bertram G. Goodhue. Construction crews should coordinate with skilled artisans in a phased stairway restoration that permits continued access to the church. The church architects should be asked to provide design and critical stabilization compliant with New York City building codes. Conservation of the existing treads should be preferred. Replacement should be in kind and minimal.

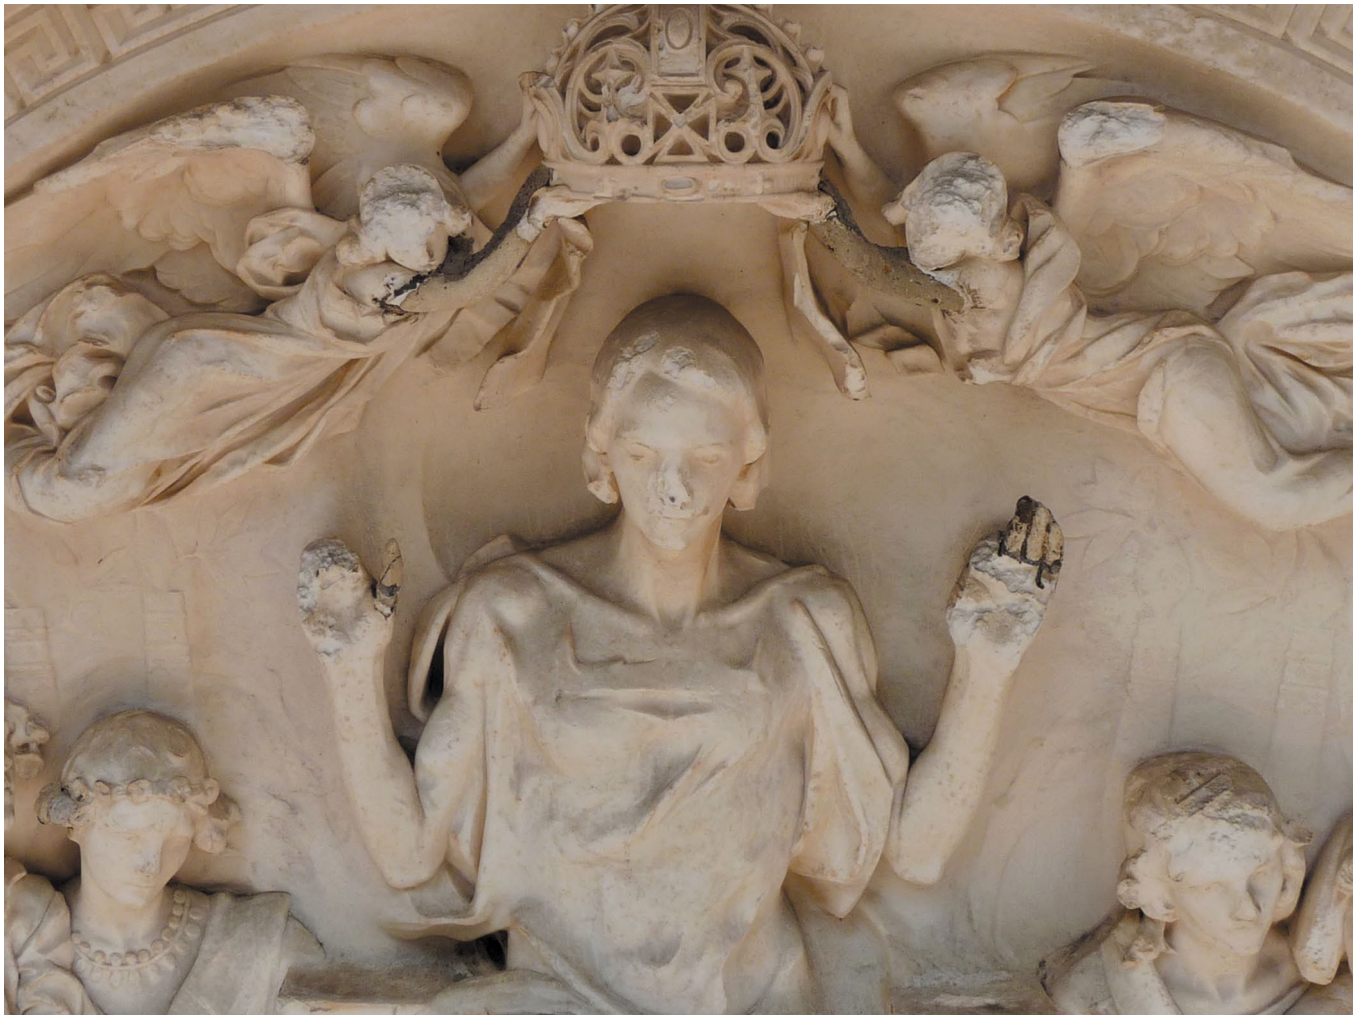
Excelsior noted an issue of concern of **Loss** in the form of **light to heavy erosion** on most iconographic sculpture of the Triple Portal. In particular, **heavy erosion** of the prominent, carved-in-the-round marble forms of the central tympanum and frieze exhibit fragile, friable

surfaces and significant loss of critical sculptural features. The losses are progressive, as seen in the photographic record, and by several undocumented previously applied cementitious patch repairs that are adjacent to them. The tympanum and frieze exhibit multiple in plane and hairline cracks that appear stable but are still of concern. Patch repairs on the limestone sculpture have failed, and the mortar is deteriorated in the joints of the friezes.

Central Tympanum with Significant Loss of Critical Sculptural Features.

Following cleaning, the fragile, friable surfaces of the central tympanum should be carefully assessed to determine the type and the extent (silicon dioxide conversion and/or silicic ethyl ester or ethyl silicate complexes) of consolidation treatment required to stabilize them. Defining treatment goals and then applying and assessing consolidation performance will help inform the feasibility of subsequent conservation activity. If deemed appropriate, adding in-kind "dutchman" or composite cast sculptural restorations may be realized. Digital scan data can be used to support remote carving and modeling activity, including creating 3D prints of existing sculptural surfaces, which can permit precise integration of restorations into the historic fabric. This approach reduces the need to access the Triple Portal repeatedly, minimizing disruptions to the church and incidental wear and tear of vulnerable marble.
