ST. BARTHOLOMEW'S CONSERVANCY
RESTORING A NATIONAL HISTORIC LANDMARK
St. Bartholomew's Church and Community House

RESTORATION AND PRESERVATION PLANS

Restoring and Preserving the St. Bartholomew's Church and Community House Exteriors

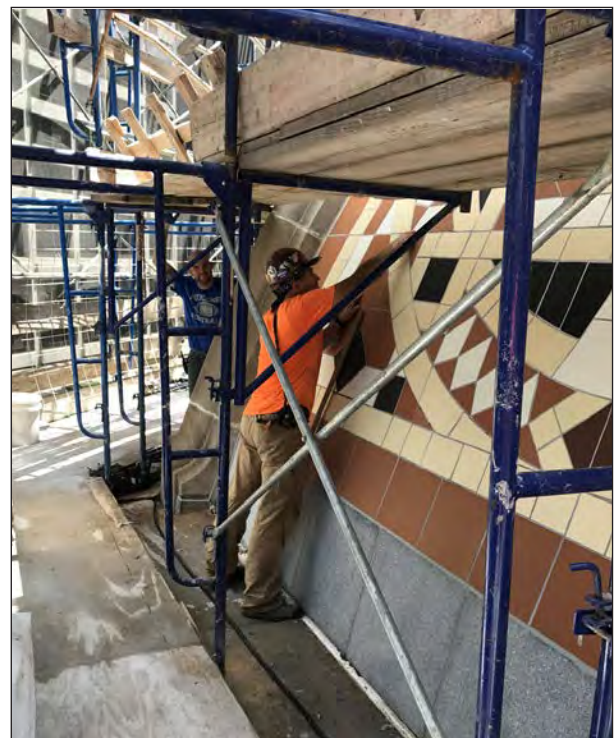
■ *Construction workers installing new Dome tiles*

The Conservancy's initial focus has been on raising the funds necessary to commence restoring, preserving and maintaining the Church Building's signature Great Dome. In 2006 St. Bartholomew's launched its first-ever capital campaign and followed up with a second, wholly internal one, in 2011. Both campaigns raised funds restricted to Great Dome restoration, but not enough to actually commence work. Beginning in 2014, however, the Conservancy was successful in closing the approximately \$1.8 million fundraising gap, allowing the yearlong project to begin on July 1, 2016.

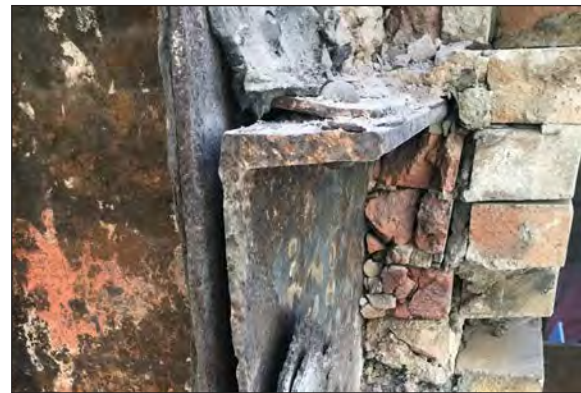
■ *Engineering probe of the Community House Facade, showing the effects of steel expansion on a masonry wall.*

Expert probing has revealed that among the multiple brick sizes used, the largest consistently displays surface exfoliation. Fortunately, because of its localized nature, the condition can be remedied on the four Church Building facades using minimally invasive techniques. The same cannot be said of the Community House, which has additional problems stemming from construction practices of the late 1920's that placed exterior masonry walls in close contact with steel

frames and concrete slab flooring. Over time, water infiltrated the walls and rusted the embedded steel supports, causing them to expand.

Such steel expansion pushes exterior masonry walls outward, further accelerating the rate of deterioration by allowing even more water to penetrate. This accounts for a higher square-foot cost for restoration and preservation of the Community House facades than for similar work on the Church Building.

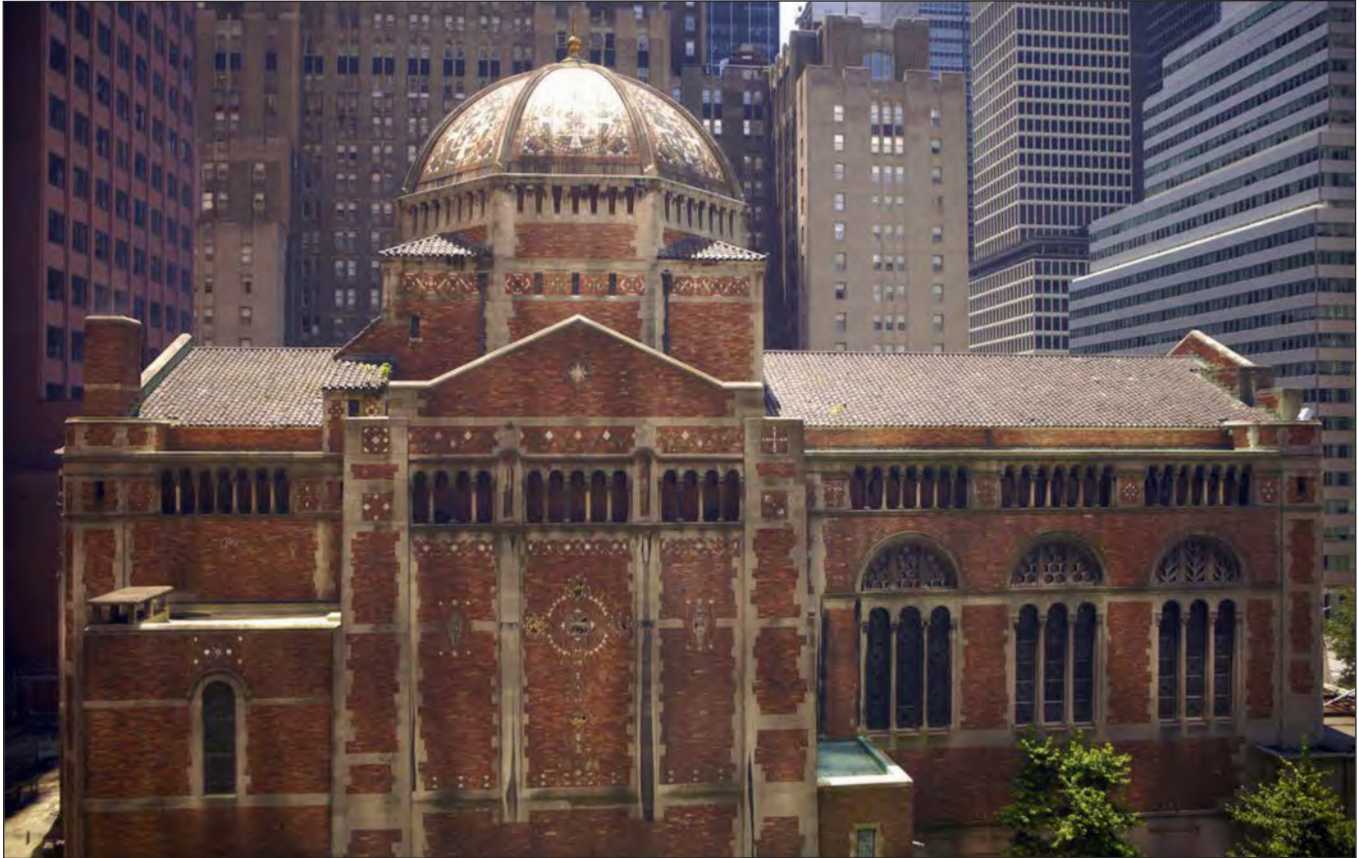
■ *St. Bartholomew's Church, North Facade with decorative Byzantine inlay and Gallery Colonnade.*

Among New York City's most recognizable buildings, St. Bartholomew's Church and its adjacent Community House were once quite colorful. Conservancy-funded restoration seeks to return them to their original vibrancy. Stylistically Romanesque with Byzantine ornamentation, the Buildings' facades are artful brick and limestone compositions. The multiple size bricks feature an array of iron spot colors randomly placed throughout, resulting in a rich interplay of mottled colors, patterns and motifs. Interspersed among the brickfields on the Church Building is an equally rich array of limestone and marble units, including dimensioned blocks, quoins, molded sills,

ledges, carved friezes, columns, capitals, and window tracery. Recalling architectural antecedents in Italy, Istanbul, and England, marble, granite, and limestone are also integrated into the Gallery Colonnades atop the Church Building and at mid-level on the Community House.

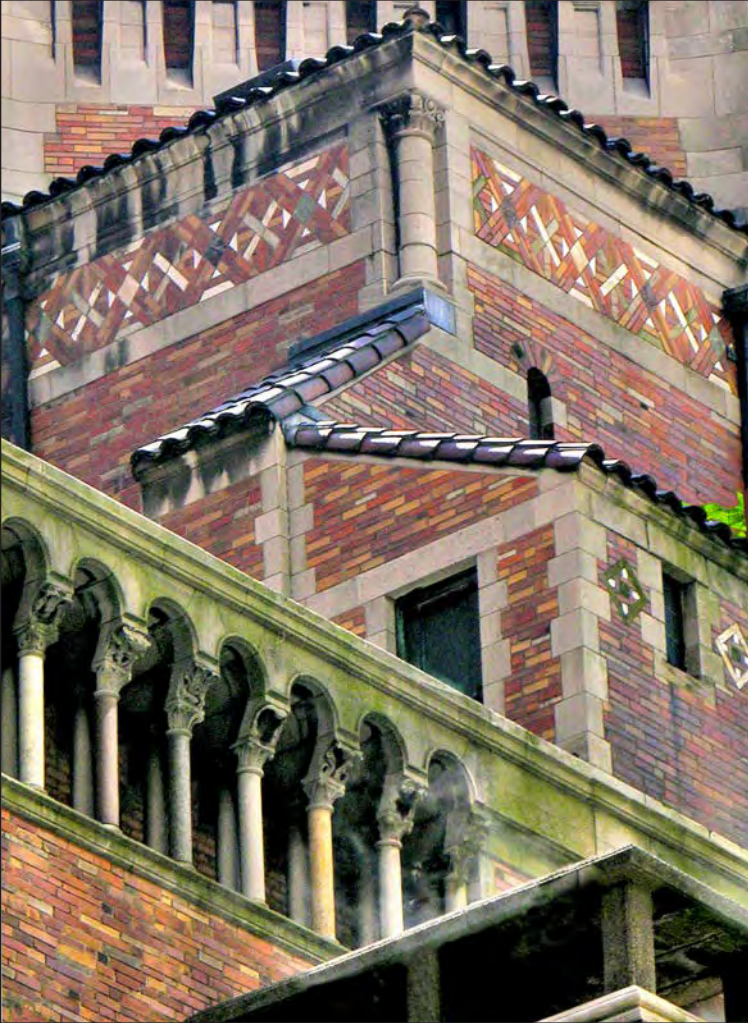
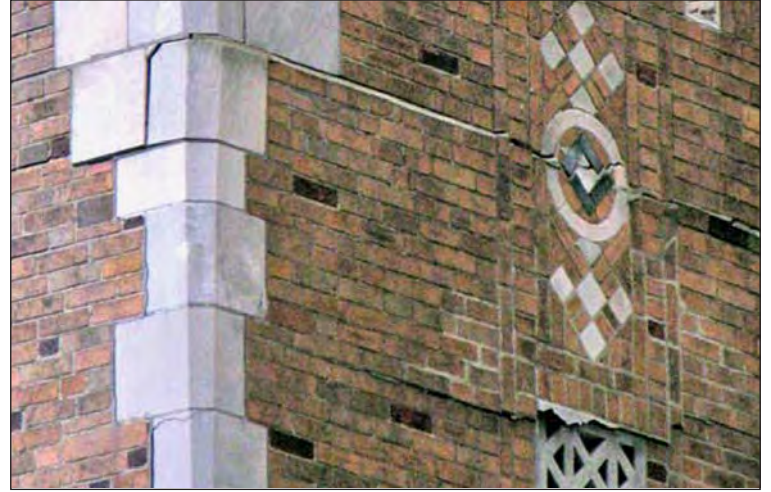
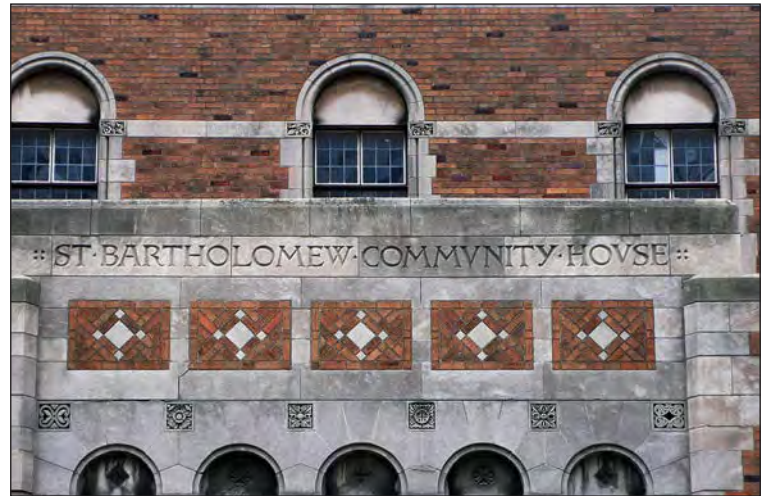
■ Detail of the Church brickwork and limestone Colonnade showing deterioration. Top right: Detail of the Community House brickwork and limestone revealing substantial cracking. Lower right: Detail of the Community House west facade.

A conditions assessment has shown that the facades' mortar joints are surprisingly thin, given the generally coarse nature of the sand they contain, and a full repointing of all the facades is likely warranted to achieve a uniform result. Much of the limestone ornamentation, including window tracery, is similarly compromised and requires replacement.

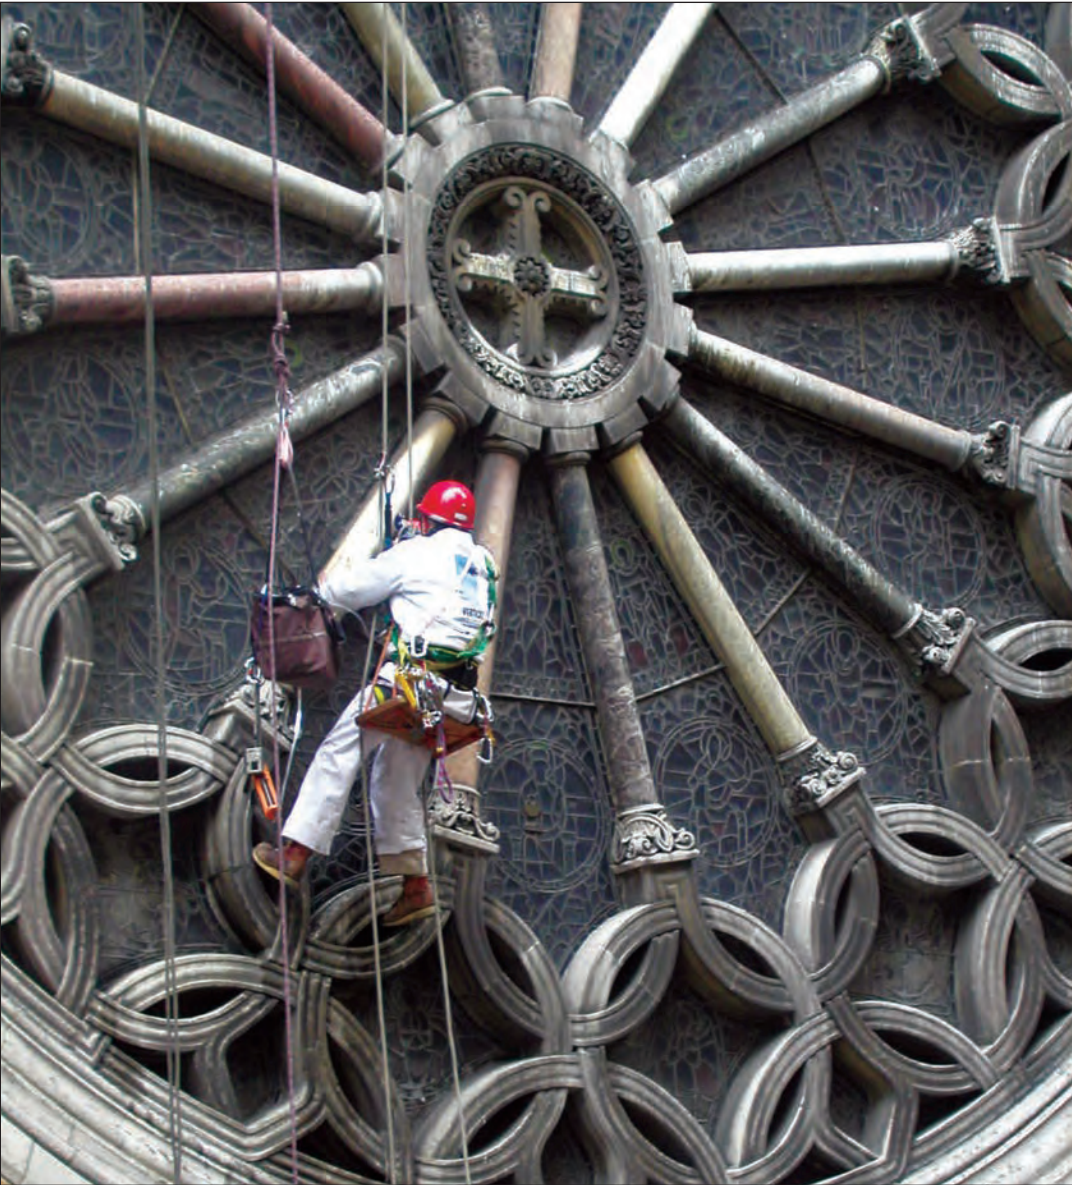
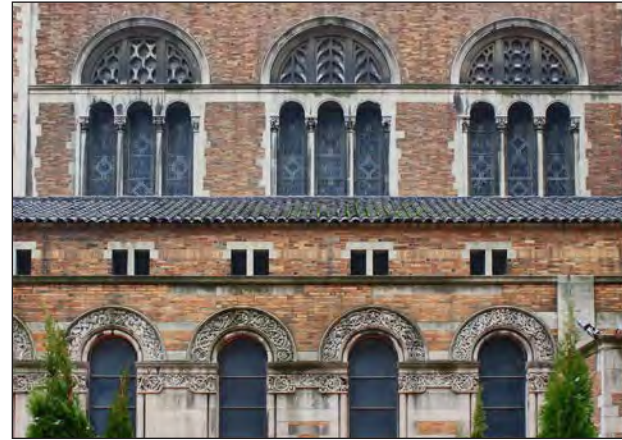
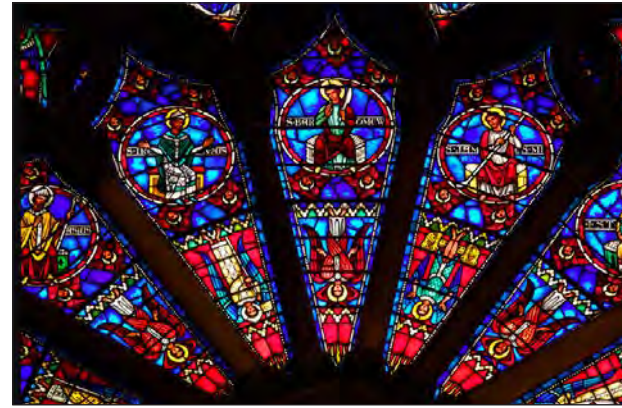
■ Left: Inspection of the Wheel Window's tracery; Top right: Detail, South Facade windows; Lower right: Interior detail of the Wheel Window.

Park Avenue from the congregation's prior Madison Avenue location. The so-called Wheel Window (24 feet in diameter, 75 feet in circumference), is the largest. Its stained glass was installed in 1943, a gift of Emily Vanderbilt White. In addition to the replacement of much of the limestone window tracery, restoration and preservation of the windows will require removing decades of soot and grime before applying a special sealant.

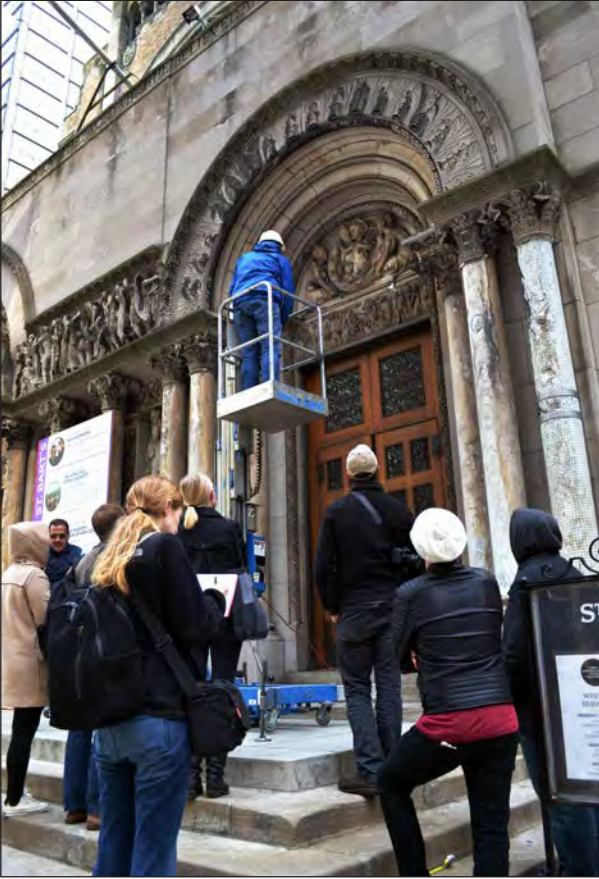
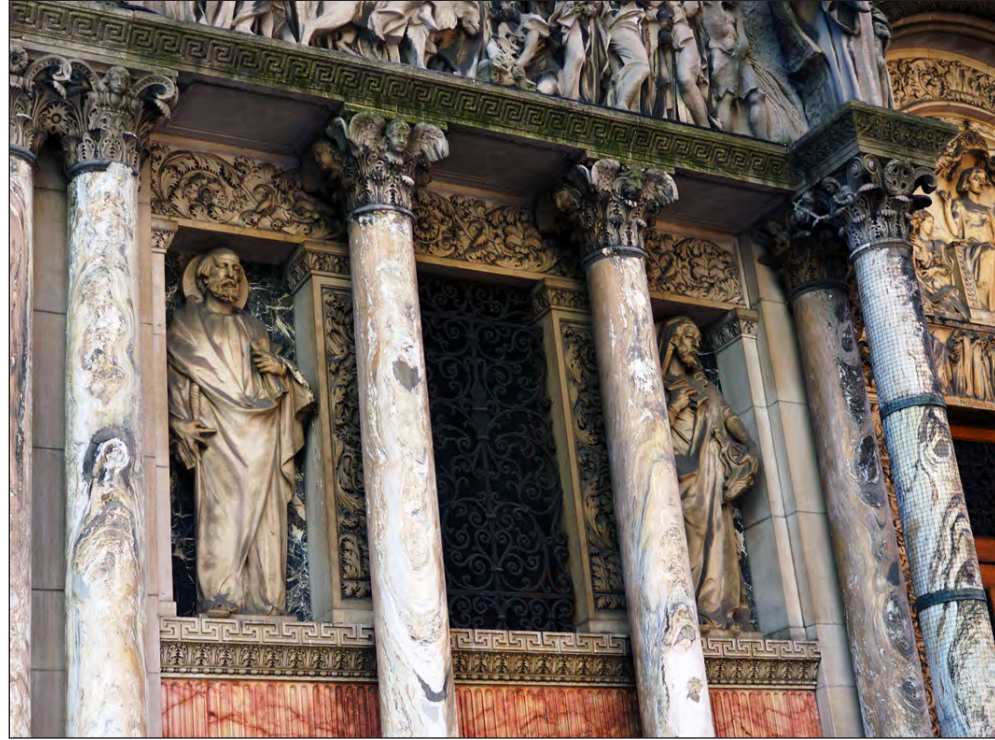
■ *Left: Columbia University Graduate Students and Faculty, in collaboration with the Conservancy, examine the Triple Portal conditions. Right: Triple Portal detail highlighting deterioration of the Cipollino marble columns.*

Estimating the cost of restoring and preserving the Triple Portal has been facilitated by a conditions assessment conducted by faculty and graduate

students at the Columbia University Graduate School of Architecture Planning & Preservation / Historic Preservation Program. One recommendation to be considered from the study, if feasible, is to restore and permanently seal the Cipollino columns as an alternative to replacing them. Substantial work, however, will need to be done on the Portal's myriad stone sculptures and on the Bronze Doors, which currently cannot be opened and closed and therefore are not visible from Park Avenue. The broad bank of Limestone Steps leading up to the Triple Portal is eroded beyond repair and must be replaced, potentially with a more durable stone acceptable to the New York City Landmarks Commission.

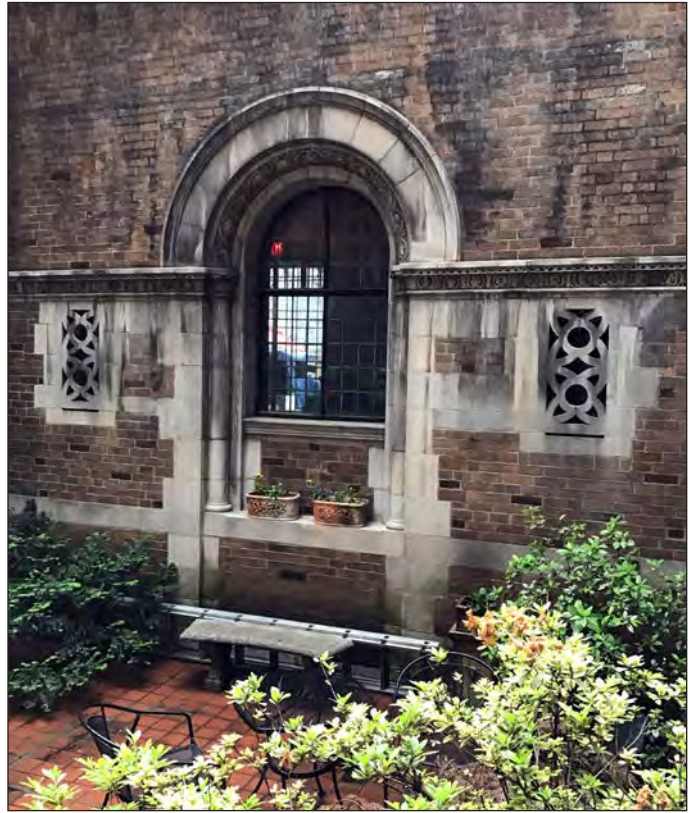
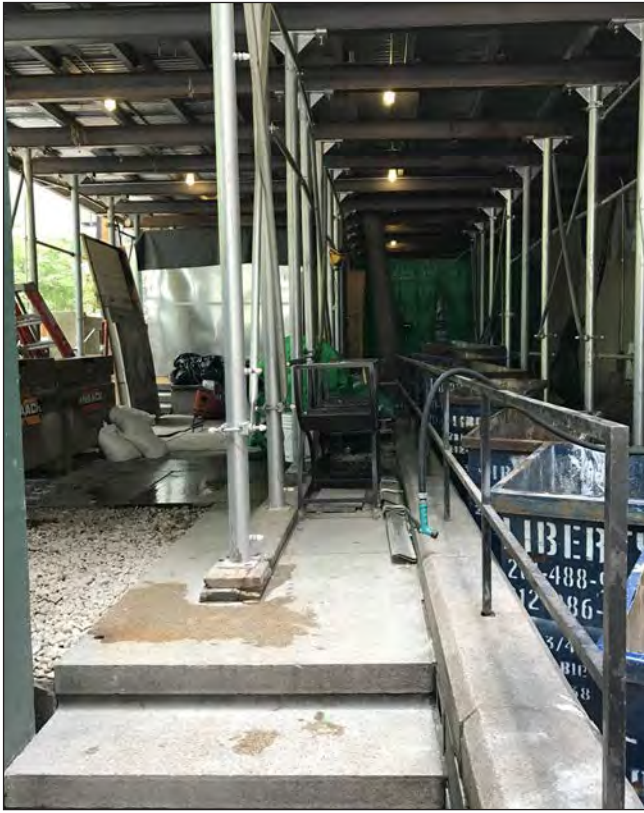
■ Left: The site of the Cheatham Garden, now being used for scaffolding. Right: A view of the Garth, showing the West Wall in need of restoration.

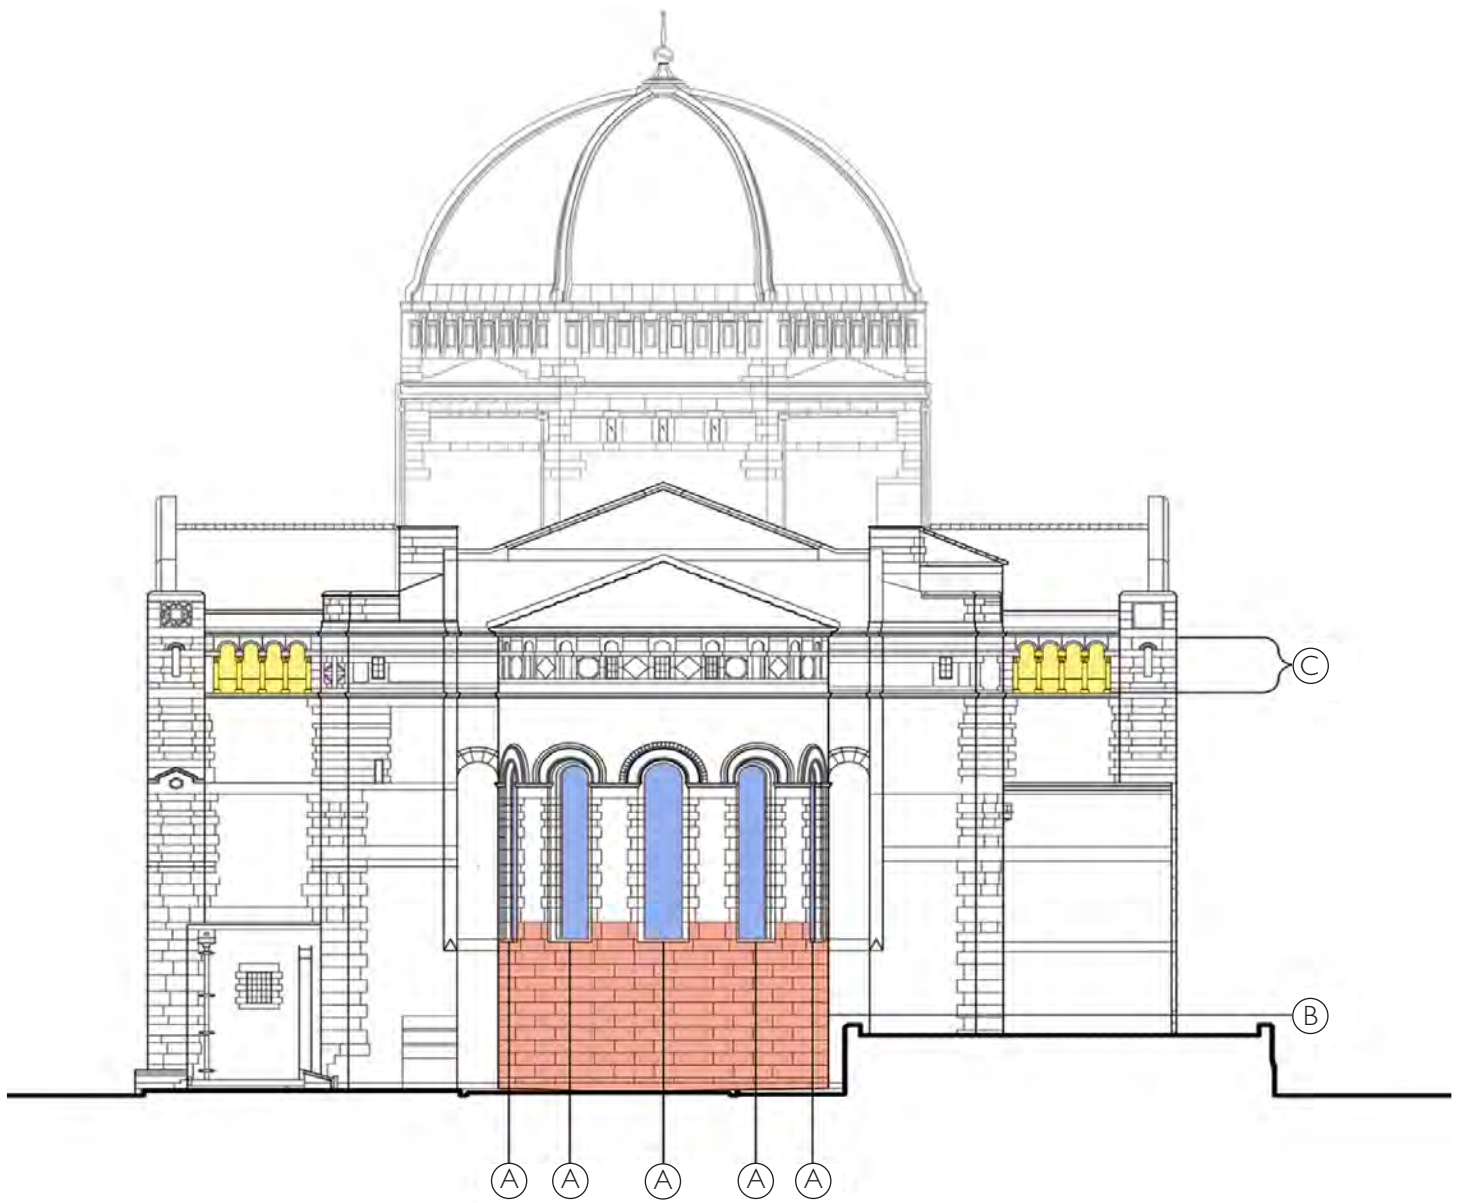
St. Bartholomew's Church East Facade

- Restoration Estimate
 - (A) Windows
 - (B) Brick and Limestone Masonry
 - (C) Gallery Colonnade:
- East Facade Total: \$1,675,000

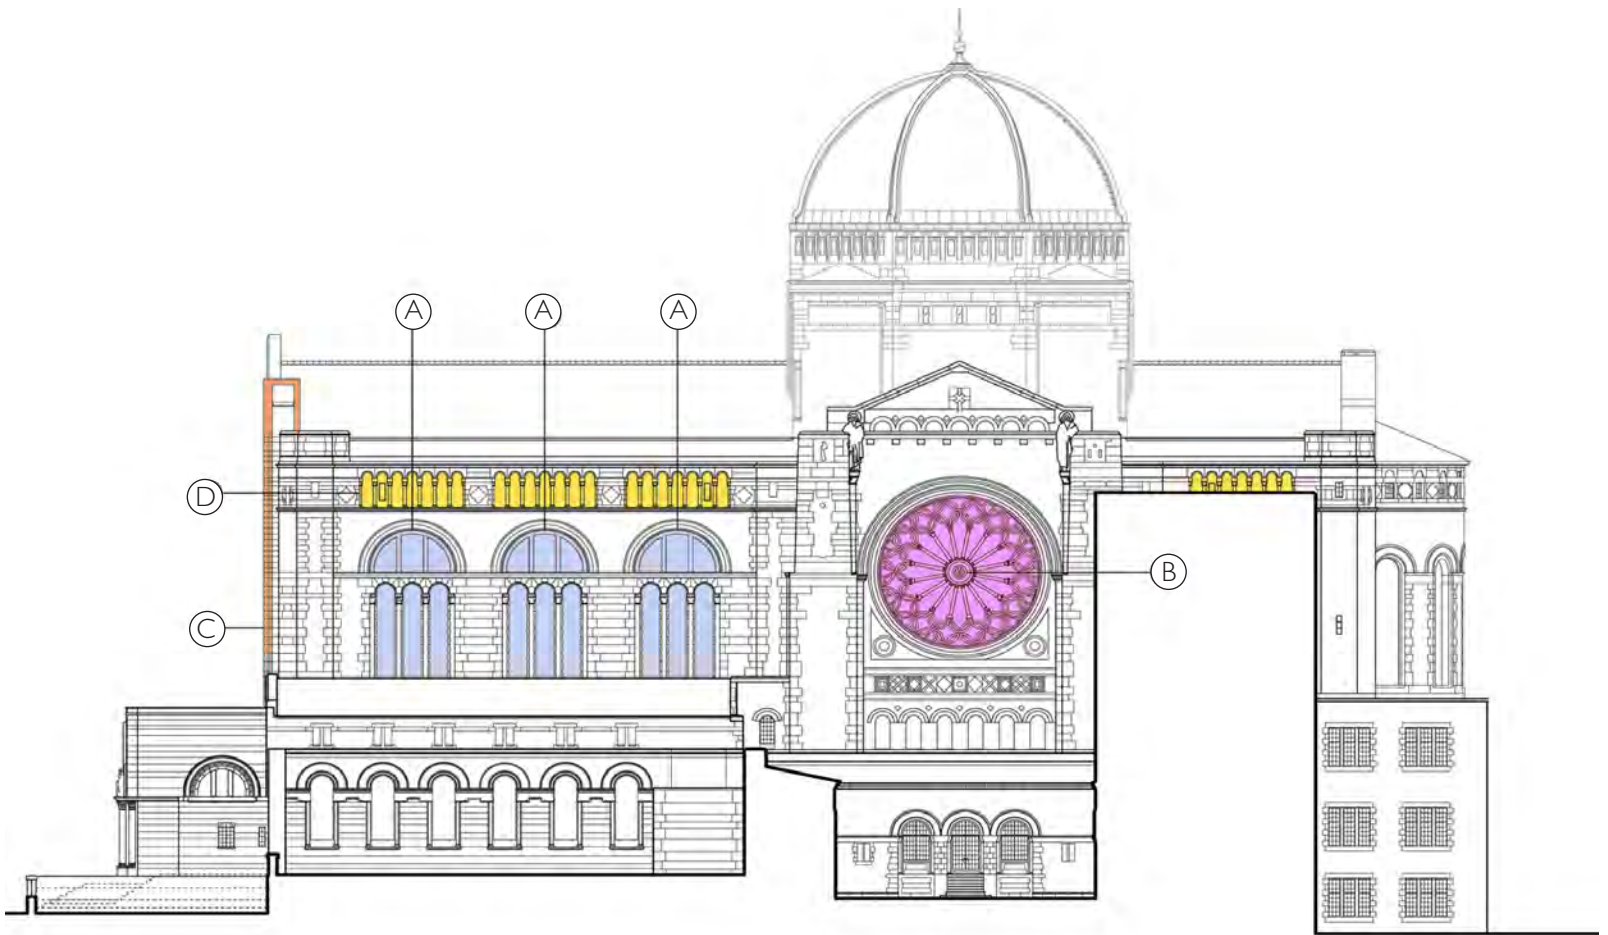
St. Bartholomew's Church South Facade

- Ⓐ Windows including the
- Ⓑ Wheel Window
- Ⓒ Brick and Limestone Masonry
- Ⓓ Gallery Colonnade

South Facade Total: \$2,800,000

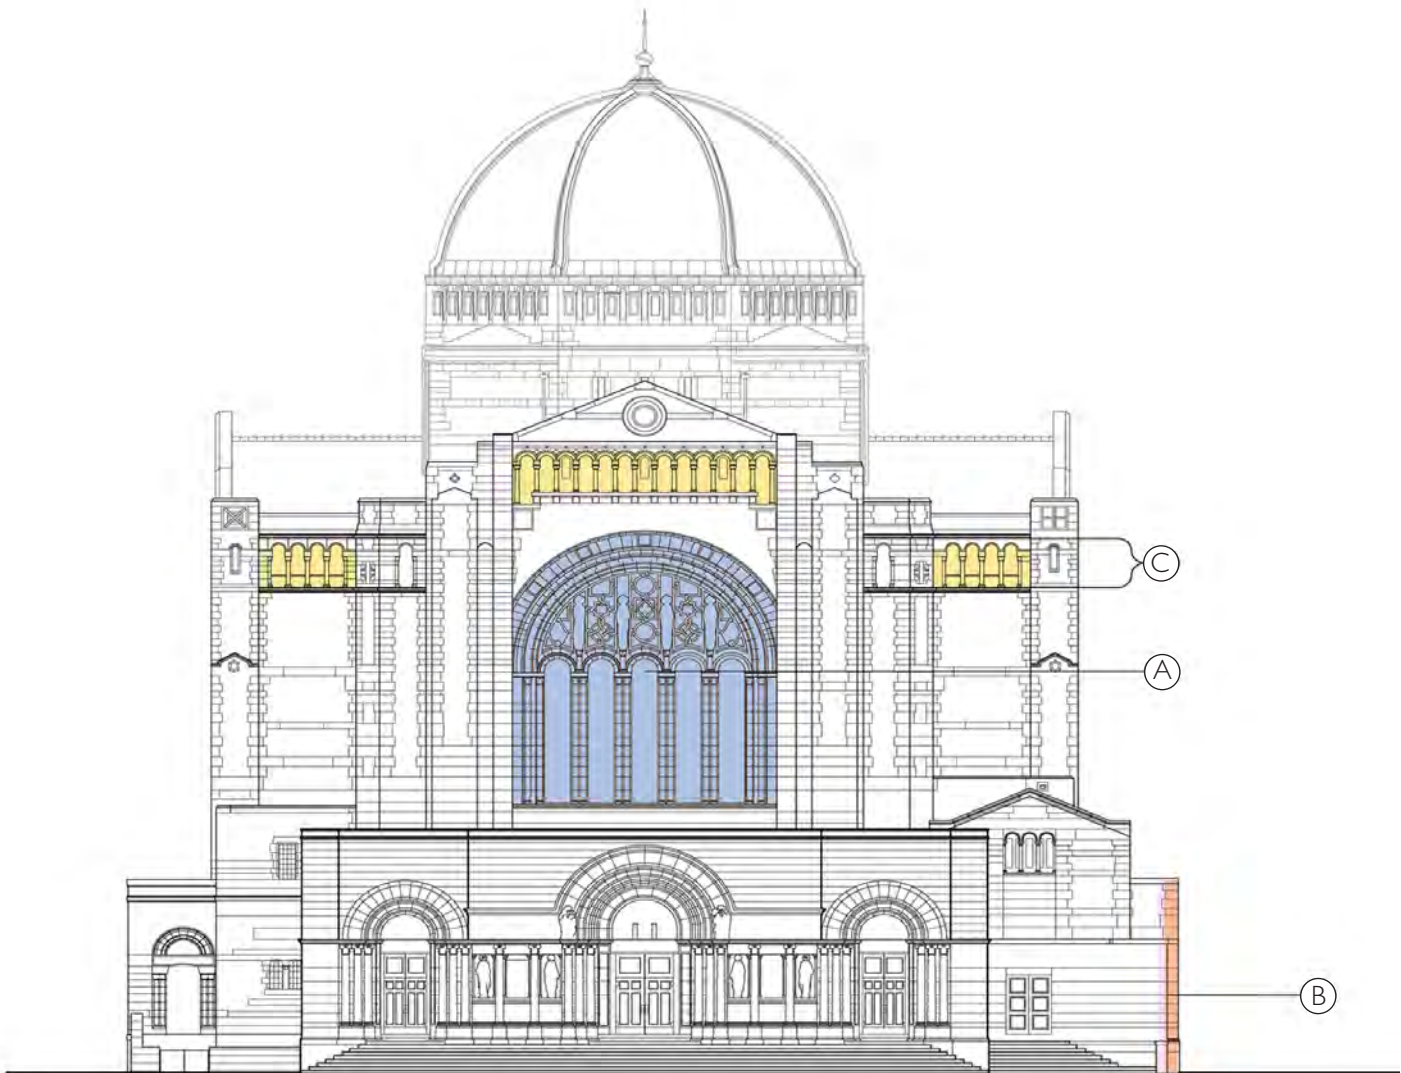
St. Bartholomew's Church Upper West Facade

- Ⓐ Windows
- Ⓑ Brick and Limestone Masonry
- Ⓒ Gallery Colonnade

Upper West Facade Total: \$1,700,000

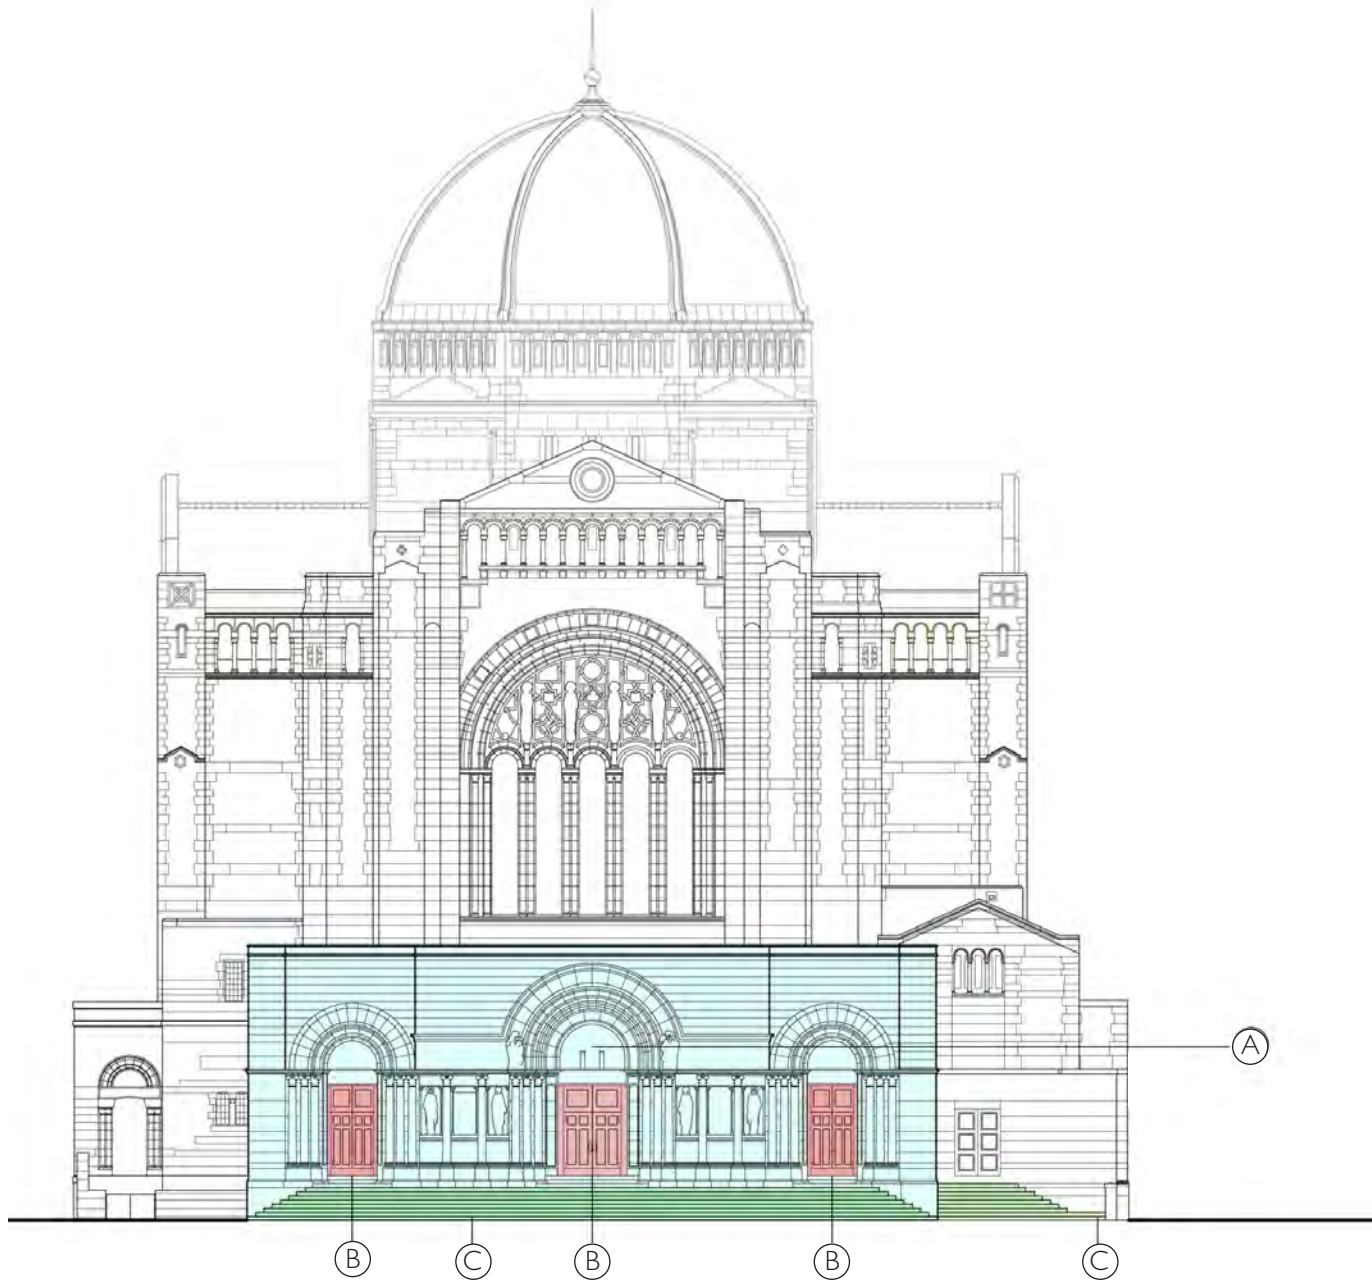
Portals, Bronze Doors, Limestone Steps

- (A) Portal Stone
- (B) Bronze Doors
- (C) Limestone Steps, Platform

Portals, Doors, and Steps Total: \$3,707,345
