THE STANFORD WHITE TRIPLE PORTAL

**ST. BARTHOLOMEW'S
CHURCH**

Building Diagnostics and Conditions Survey

Columbia University
Graduate School of Architecture, Planning and Preservation
Historic Preservation Program

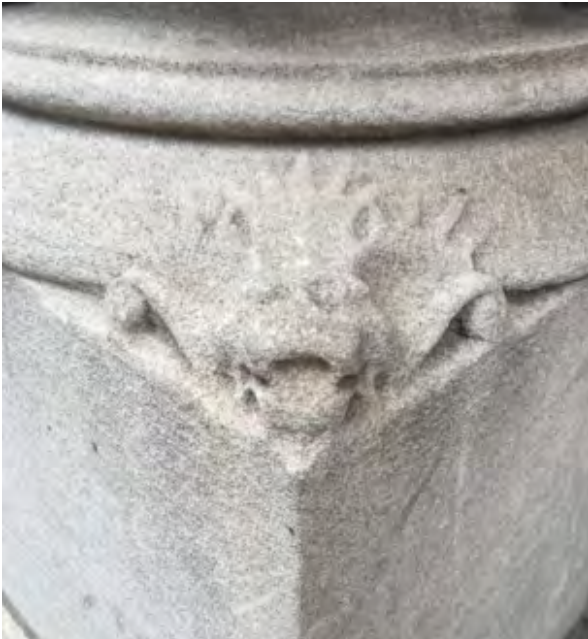
Heavy Erosion:

Heavy disintegration of the stone's surface.

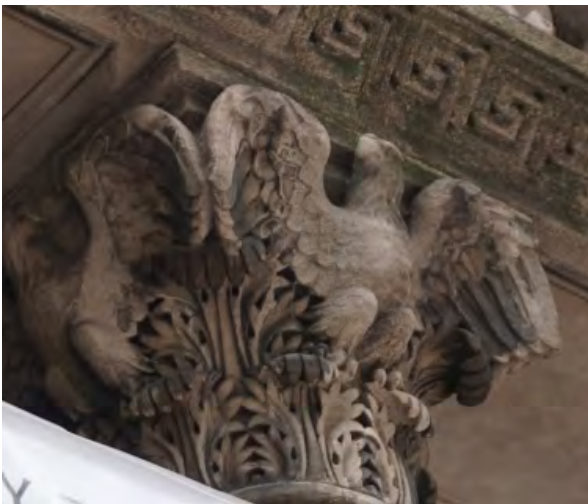
Light Erosion:

Light disintegration of the stone's surface.

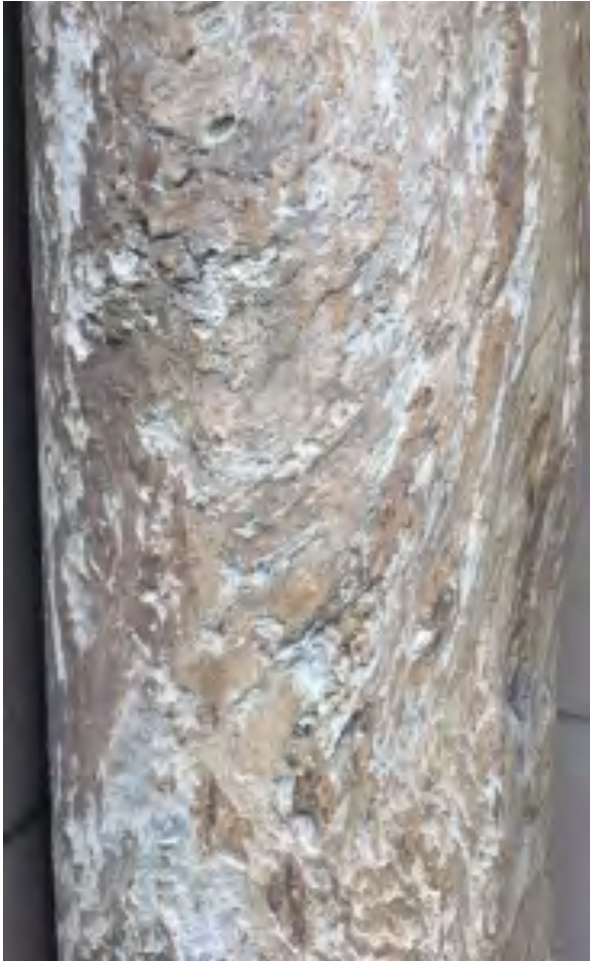
Spalling:

Chipping off of pieces on the outer surface of the material usually due to internal factors.

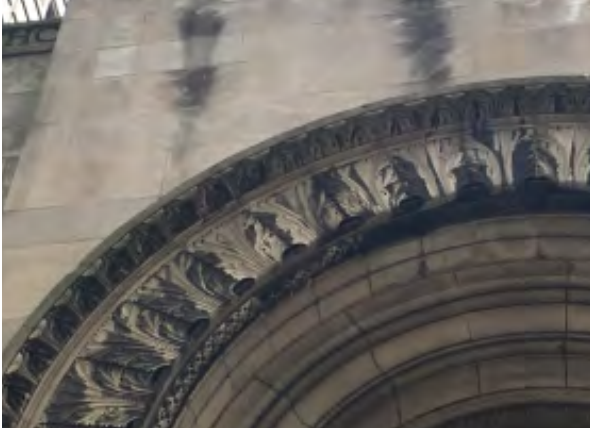
Heavy general soiling:

Alteration/change in color due to deposits of materials - heavy layer of deposits.

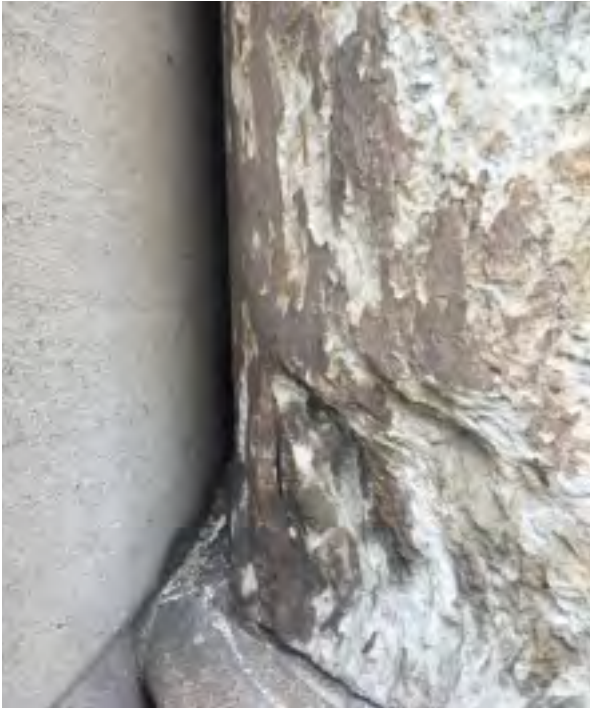
Light general soiling:

Alteration/change in color due to deposits of materials - light layer of deposits.

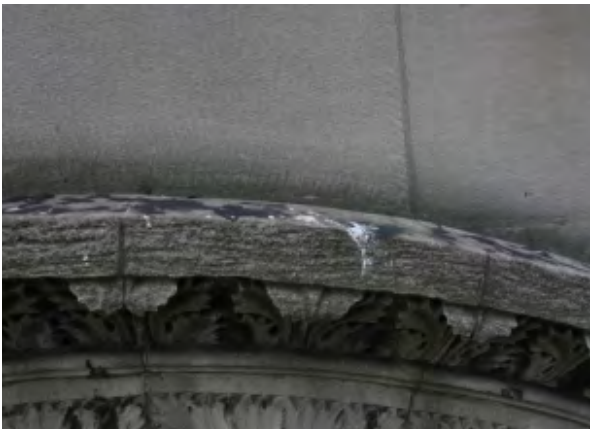
Bird excrement:

Deposits of bird excretion.

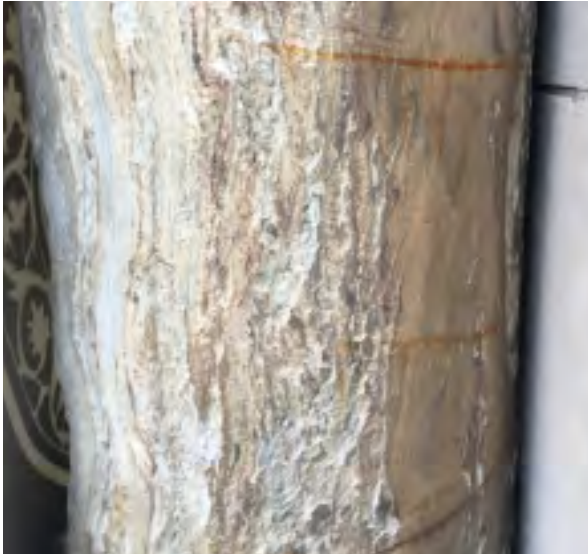
Staining:

Alteration/change in color in material imparted from another material.

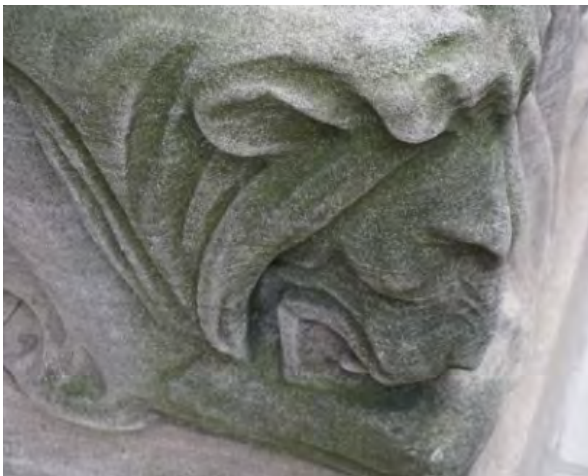
Biological Growth:

Organic growth visible on the stone's surface, typically algae, lichens, mold, plants, vines.

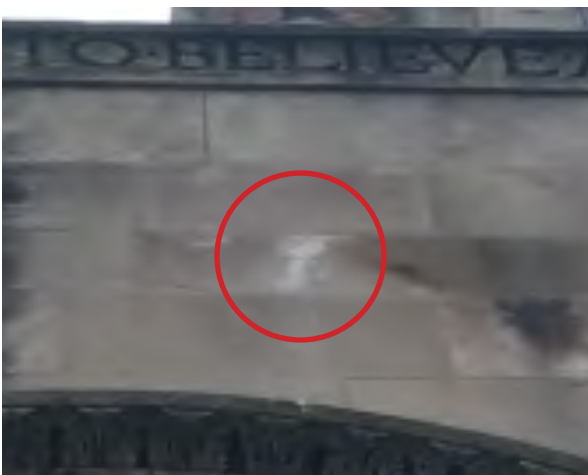
Efflorescence:

Formation of white coating on the surface due to salt migration from within the stone.

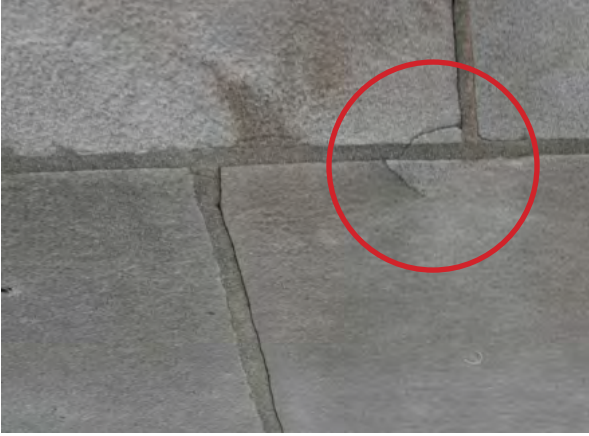
Hairline cracking:

A break in material with less than 1/16th of an inch separation.

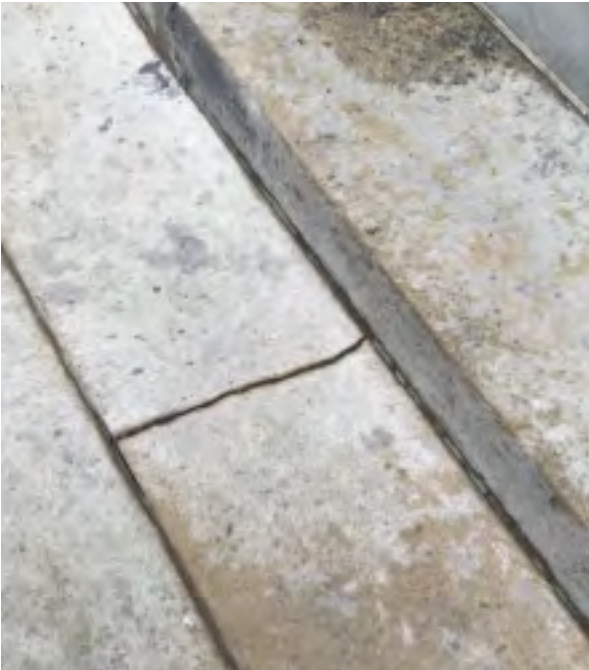
In plane cracking:

A break in material with more than 1/16th of an inch separation but with no displacement.

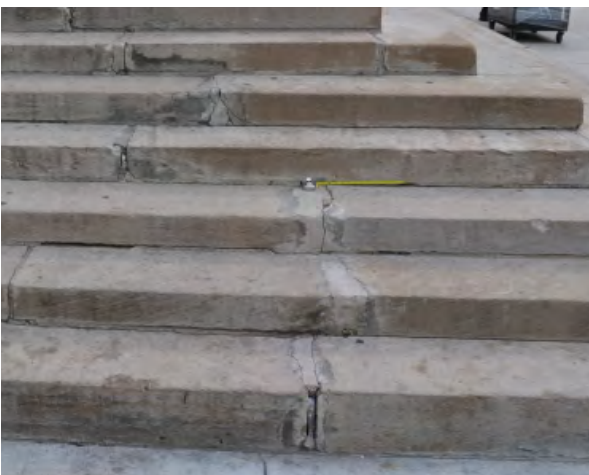
Out of plane cracking:

A break in material with more than 1/16th of an inch separation with displacement.

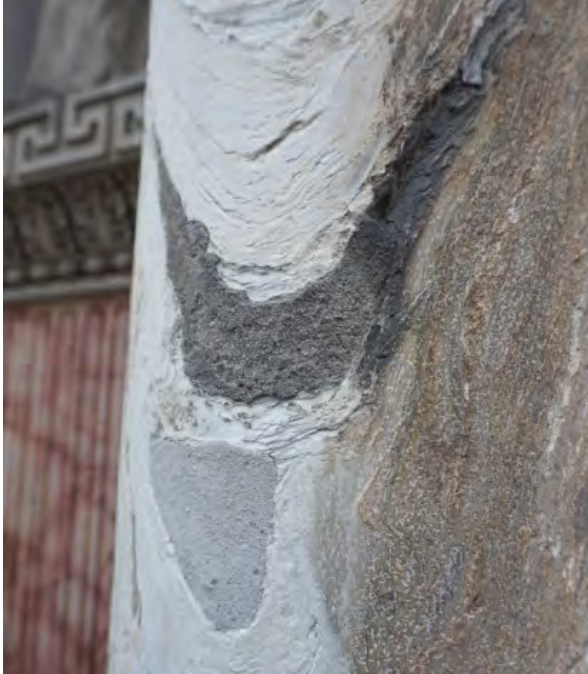
Cementitious patching:

Previous repair of cracking or material loss with a cementitious patching material.

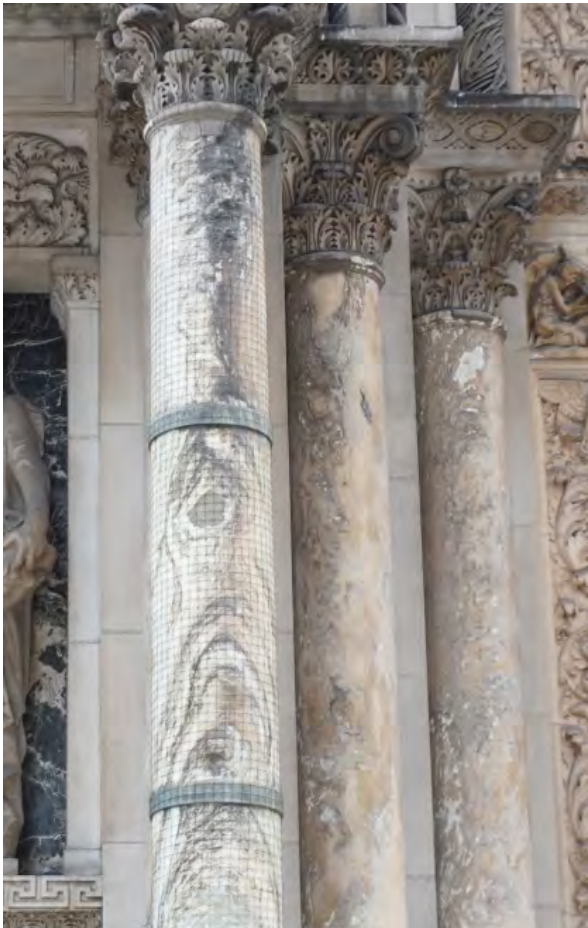
Stabilization:

Use of wire mesh netting to prevent further material loss.

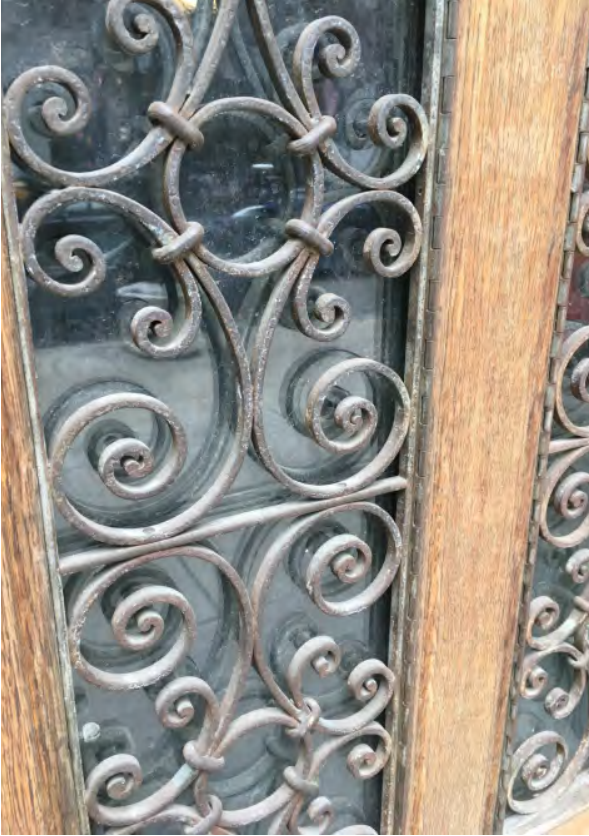
Rusting:

Corrosion of metal resulting in iron oxide deposits.

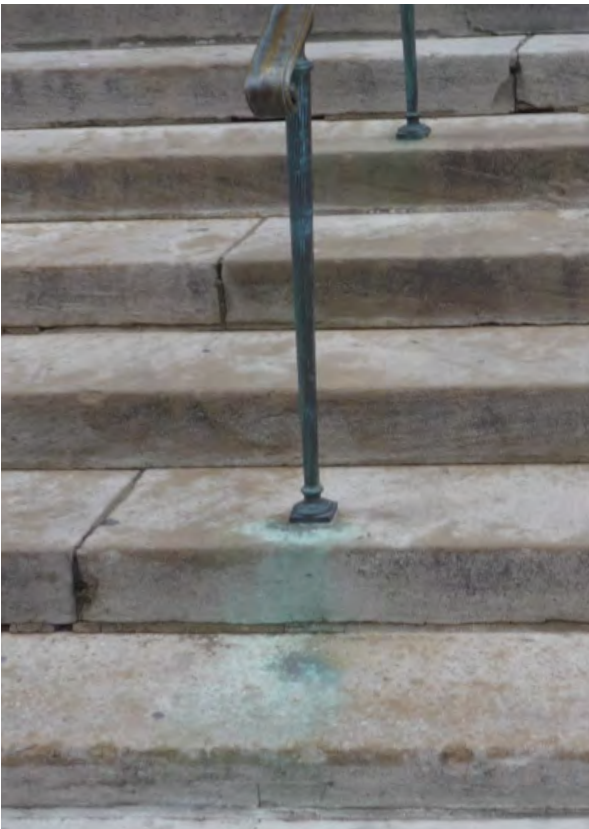
Patination:

Formation of green patina layer on copper caused by oxidation process.

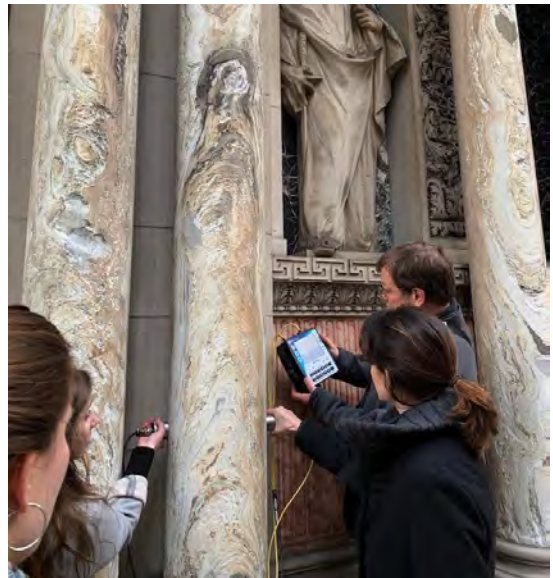
Ultrasound Pulse Velocity in use on the columns.

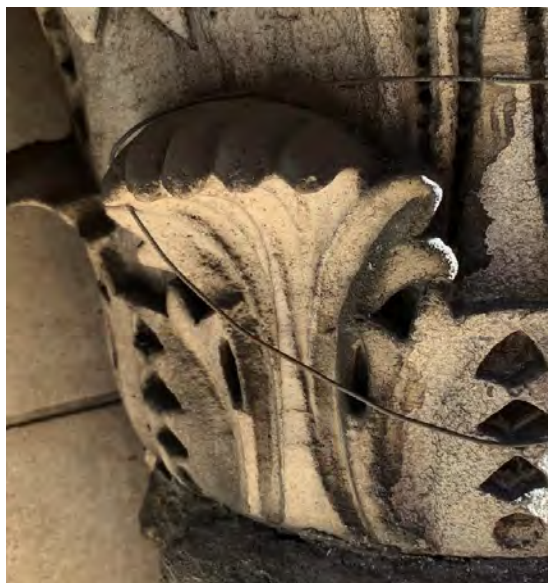
Before testing on the top of the acanthus leaf.

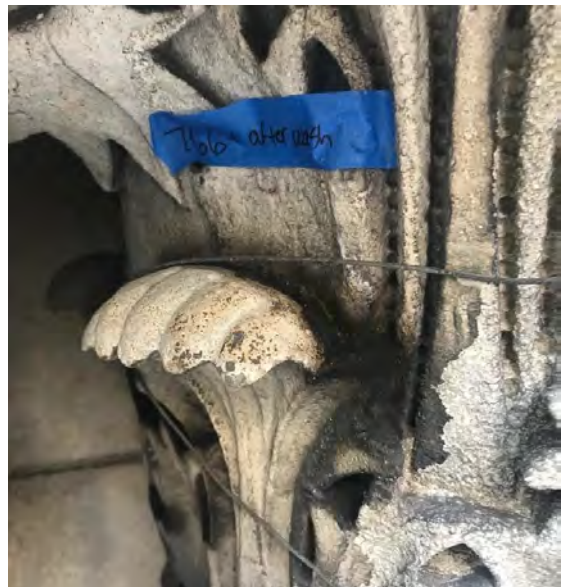
After testing on the top of the acanthus leaf.
